Appendix 8.1

Watercourse Crossing Assessment

This document details the requirements for a Watercourse Crossings Assessment at Daer Wind Farm (the proposed development) as part of Chapter 8 of the Environmental Impact Assessment Report (EIAR). The purpose of this document is to provide the relevant information associated with the watercourse crossings required as part of the proposed development and to assist in the identification of regulatory licensing requirements. It is recommended that all the watercourse crossings are designed to maintain hydrology as well as, where necessary, allowing the free passage of mammals and aquatic species.

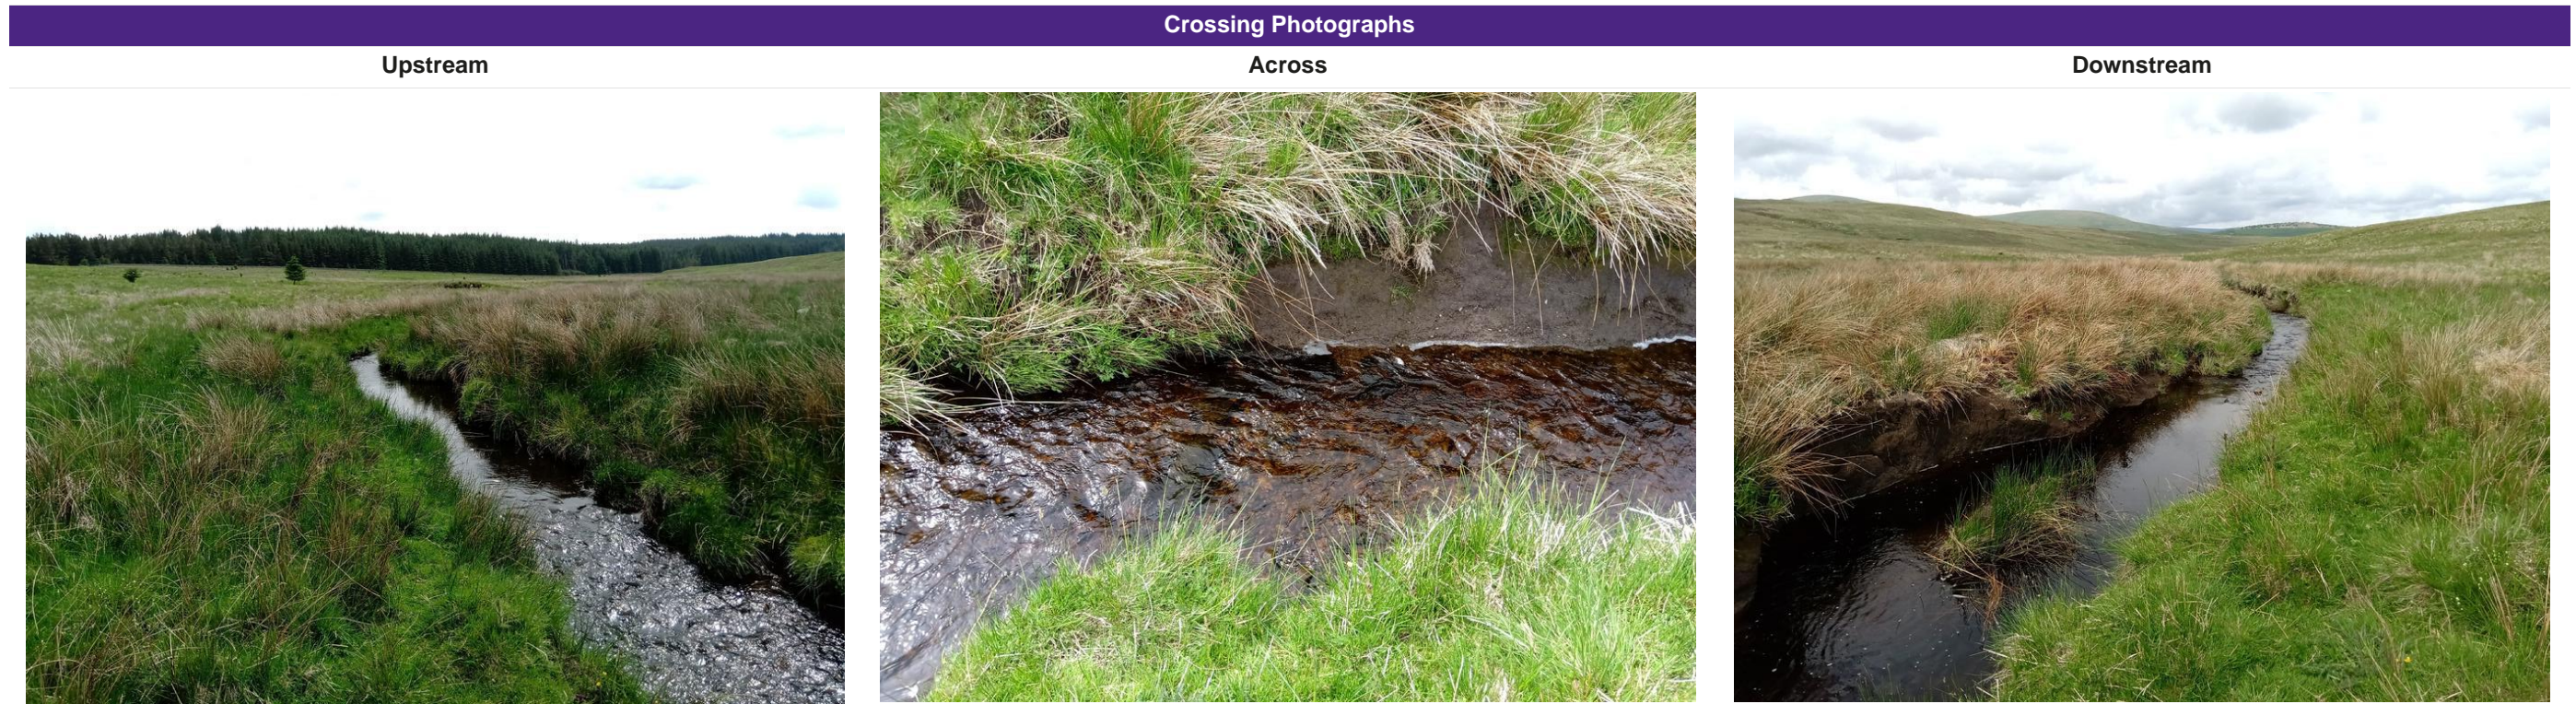
| WCX2 (299281,606287) | |
|---|---|
| <p>© Crown Copyright 2020. All rights reserved. Ordnance Survey Licence 0100031673.</p> | <p>Existing Crossing: No</p> <p>Channel: Meandering</p> <p>Gradient: Gentle</p> <p>Valley form: U-shape valley</p> <p>Bank condition: Undercut (no evidence of recent collapse)</p> <p>Bed material: Fine sand/silt, Rounded pebbles, Coarse gravel, Boulders</p> <p>Riparian corridor: Agricultural Grazing</p> <p>Flow condition: Moderate</p> <p>Water width: 1-1.2 m</p> <p>Water depth: 0.15-0.2 m</p> <p>Bankfull width: 1.2 m</p> <p>Bankfull height: 0.4-0.5 m</p> <p>Notes: None.</p> <p>CAR Auth Level: Registration</p> <p>Proposed Crossing Type: Circular Culvert</p> |

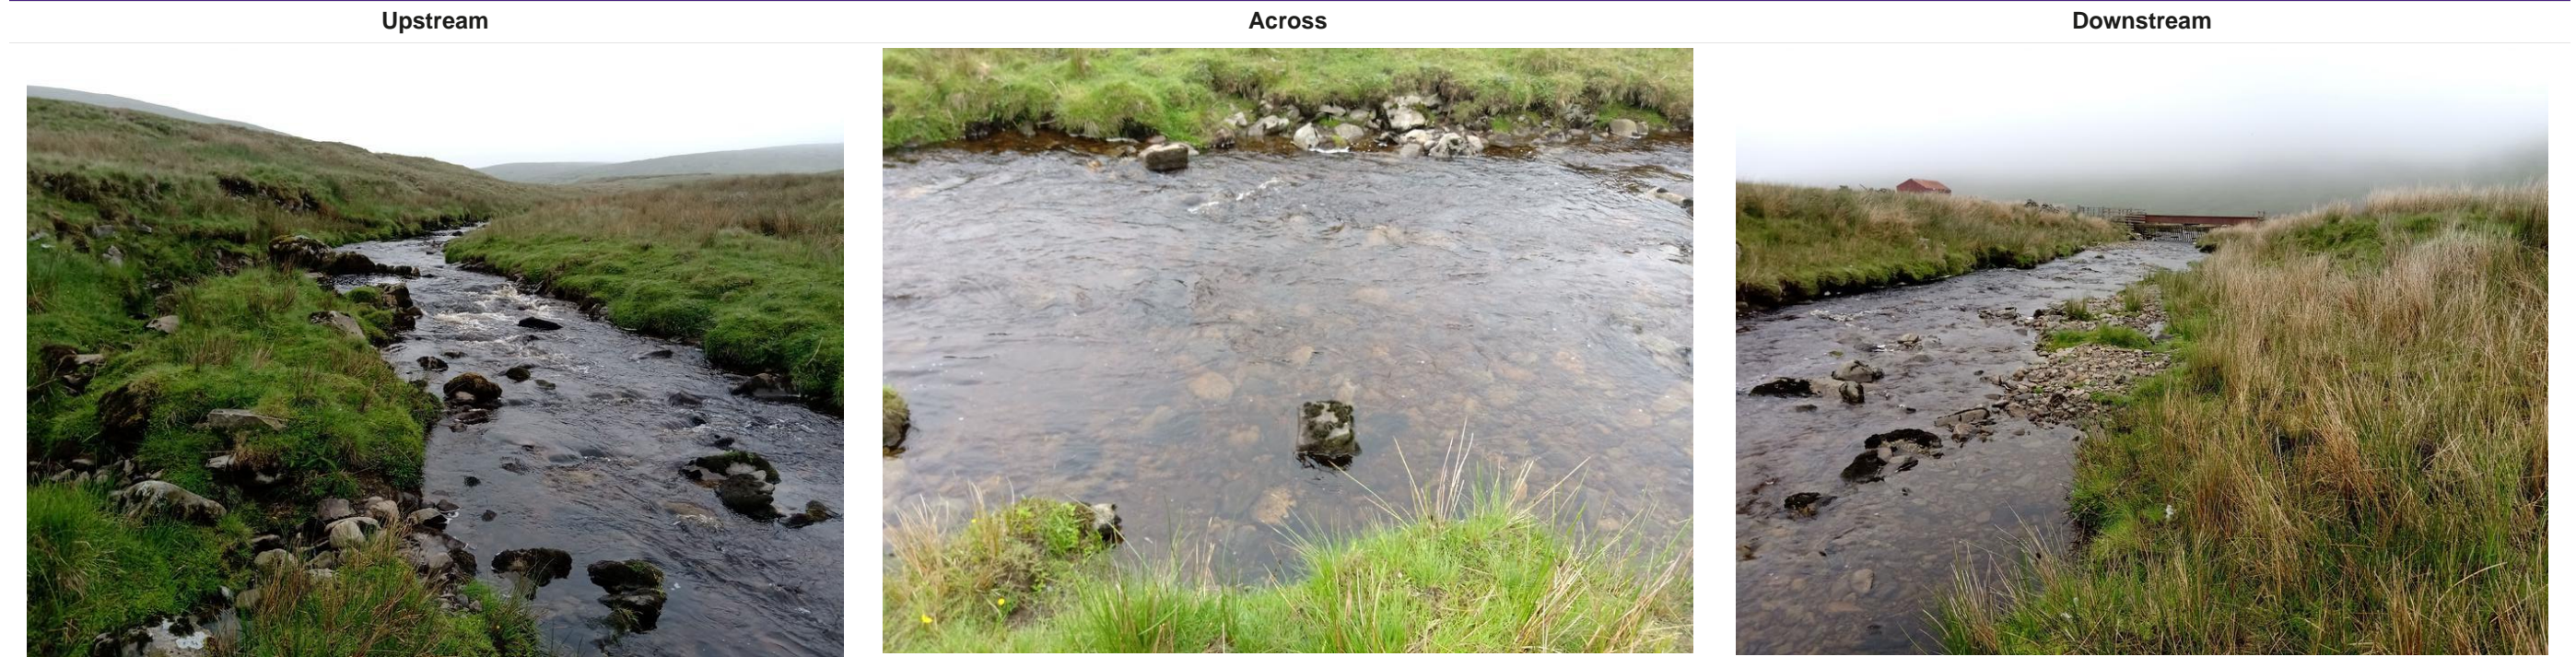
Table 8.1.5: Crossing WCX3

| WCX3 (298409,603671) | |
|---|---|
| <p>© Crown Copyright 2020. All rights reserved. Ordnance Survey Licence 0100031673.</p> | <p>Existing Crossing: No</p> <p>Channel Type: Meandering</p> <p>Gradient: Gentle</p> <p>Valley form: U-shape valley</p> <p>Bank condition: Stable, Undercut (no evidence of recent collapse)</p> <p>Bed material: Rounded pebbles, Fine sand/silt, Boulders, Coarse gravel</p> <p>Riparian corridor: Agricultural Grazing, Moorland</p> <p>Flow condition: Moderate</p> <p>Water width: 4-5 m</p> <p>Water depth: 0.1-0.15 m</p> <p>Bankfull width: 5-6 m</p> <p>Bankfull height: 0.4-0.6 m</p> <p>Notes: Evidence of previous bank slip and erosion, however not recent as now grassed over.</p> <p>CAR Auth Level: Registration</p> <p>Proposed Crossing Type: Arch Culvert</p> |

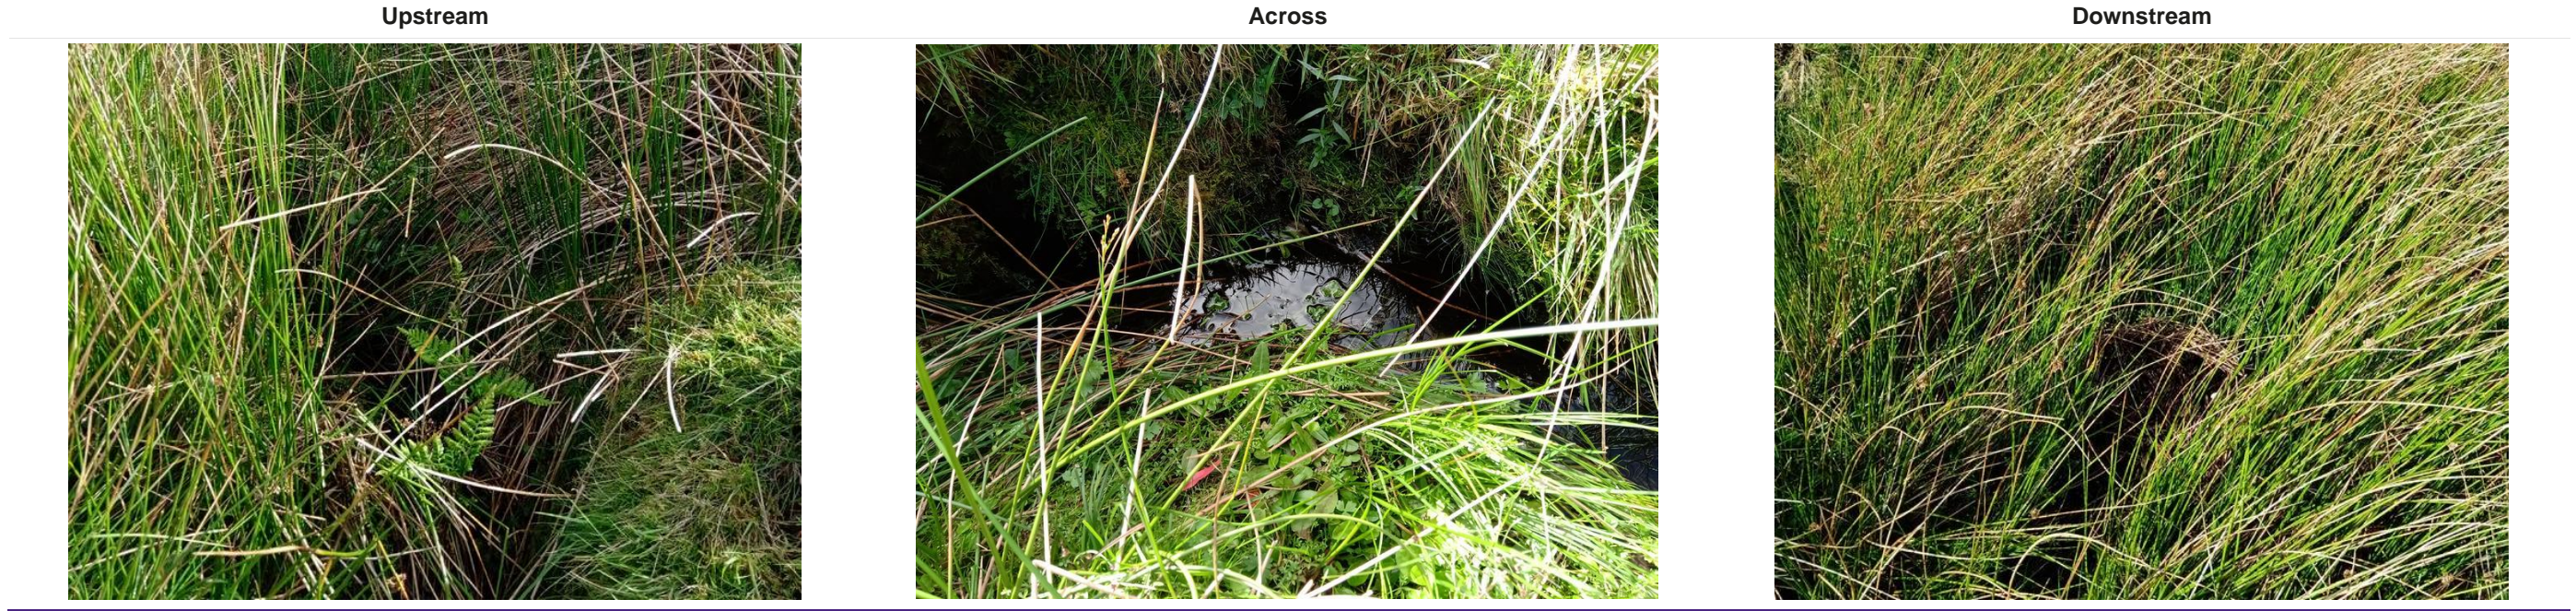
Table 8.6: Crossing WCX4

| WCX4 (298934,605118) | |
|---|---|
| <p>© Crown Copyright 2020. All rights reserved. Ordnance Survey Licence 0100031673.</p> | <p>Existing Crossing: No</p> <p>Channel Type: Meandering, Incised, Poorly defined</p> <p>Gradient: Moderate</p> <p>Valley form: Shallow vee</p> <p>Bank condition: Stable</p> <p>Bed material: Vegetation</p> <p>Riparian corridor: Moorland</p> <p>Flow condition: Moderate</p> <p>Water width: 0.2m</p> <p>Water depth: 0.2m</p> <p>Bankfull width: 0.3m</p> <p>Bankfull height: 0.2 m</p> <p>Flooded Bankfull width: 1.6 m</p> <p>Flooded Bankfull height: 0.5 m</p> <p>Notes: None.</p> <p>CAR Auth Level: Registration</p> <p>Proposed Crossing Type: Circular Culvert</p> |

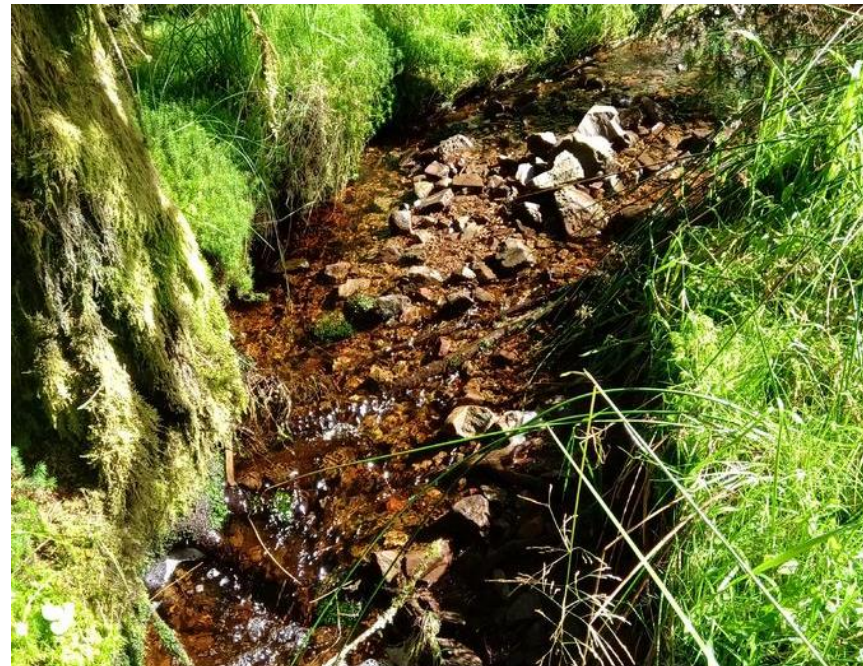
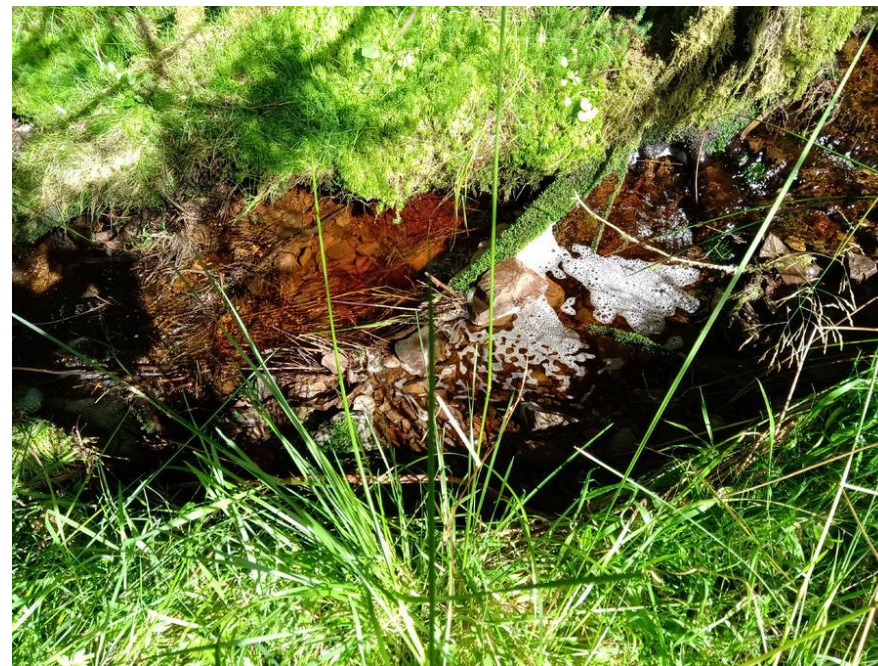
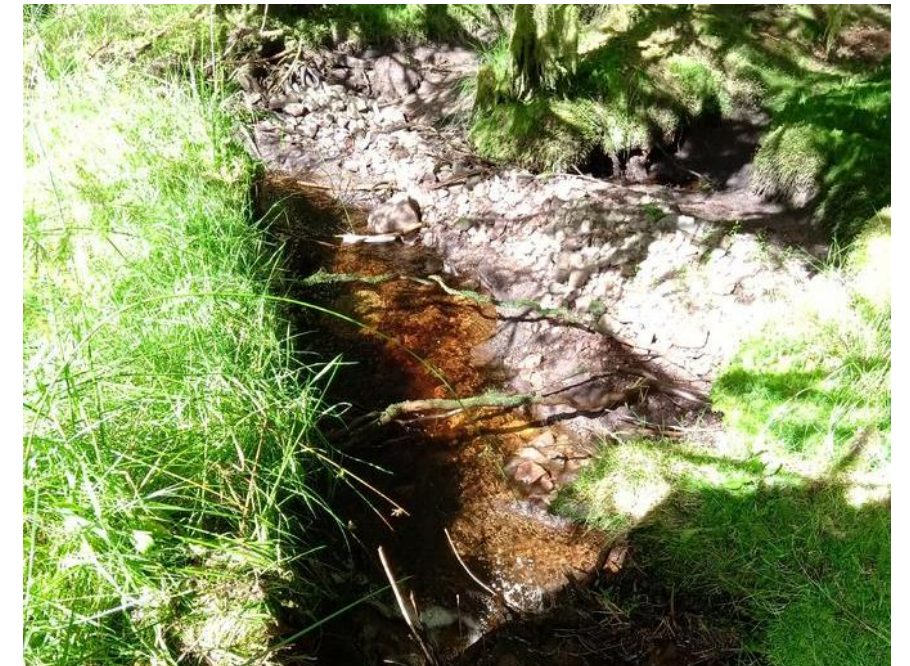
Table 8.1.7: Crossing WCX5

| Crossing Location | WCX5 (300008,605769) | Crossing Description |
|---|---|--|
| <p>© Crown Copyright 2020. All rights reserved. Ordnance Survey Licence 0100031673.</p> | <p>Existing Crossing: No</p> <p>Channel Type: Poorly defined, Incised</p> <p>Gradient: Moderate</p> <p>Valley form: No obvious valley sides, Shallow vee</p> <p>Bank condition: Stable</p> <p>Bed material: Fine sand/silt, Coarse gravel, Boulders</p> <p>Riparian corridor: Commercial Forestry</p> <p>Flow condition: Moderate</p> | <p>Water width: 1 m</p> <p>Water depth: 0.3 m</p> <p>Bankfull width: 1.3 m</p> <p>Bankfull height: 0.4 m</p> <p>Notes: None.</p> <p>CAR Auth Level: GBR</p> <p>Proposed Crossing Type: Circular Culvert</p> |

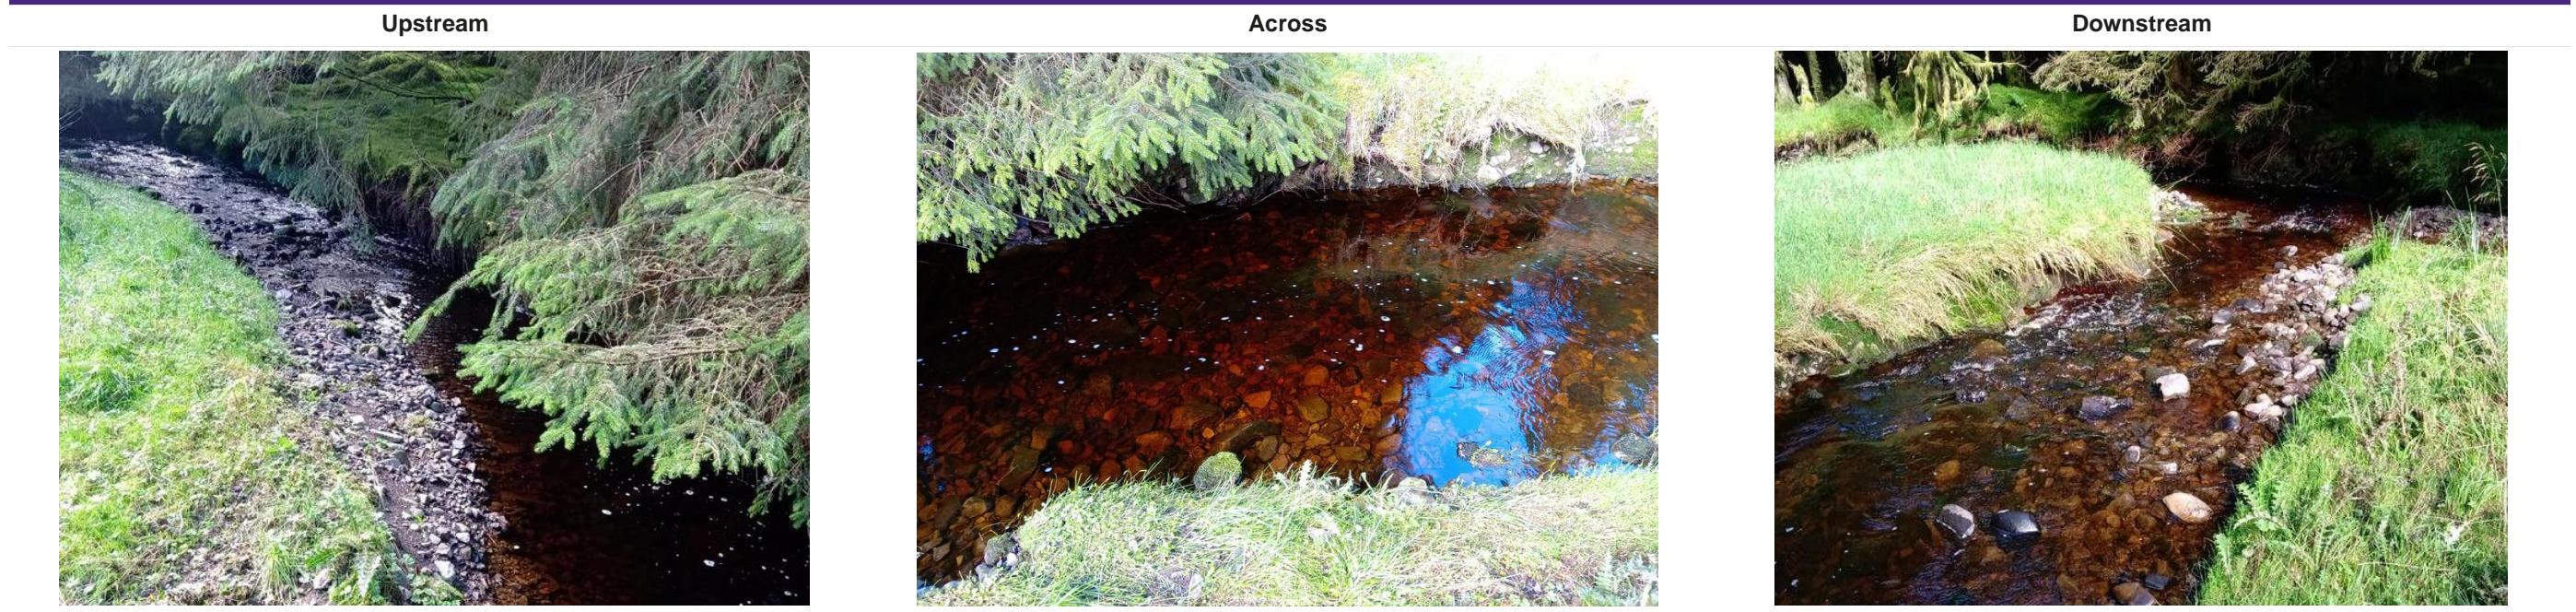
Table 8.1.8: Crossing WCX6

| WCX6 (300024,605774) | |
|---|---|
| <p>© Crown Copyright 2020. All rights reserved. Ordnance Survey Licence 0100031673.</p> | <p>Existing Crossing: No</p> <p>Channel Type: Meandering</p> <p>Gradient: Gentle</p> <p>Valley form: No obvious valley sides, Shallow vee</p> <p>Bank condition: Stable</p> <p>Bed material: Fine sand/silt, Rounded pebbles, Coarse gravel, Boulders</p> <p>Riparian corridor: Commercial Forestry</p> <p>Flow condition: Moderate</p> <p>Water width: 2.5 m</p> <p>Water depth: 0.3 m</p> <p>Bankfull width: 3 m</p> <p>Bankfull height: 0.4 m</p> <p>Notes: None.</p> <p>CAR Auth Level: Registration</p> <p>Proposed Crossing Type: Circular Culvert</p> |

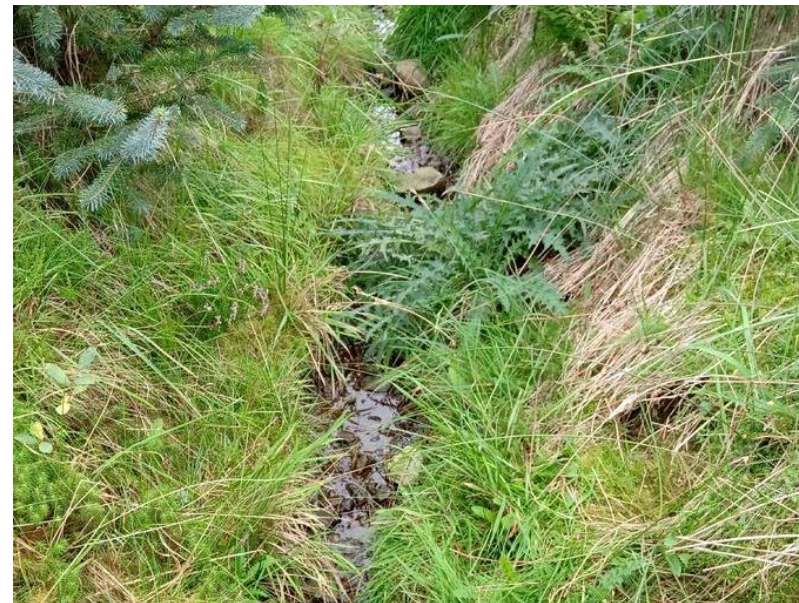
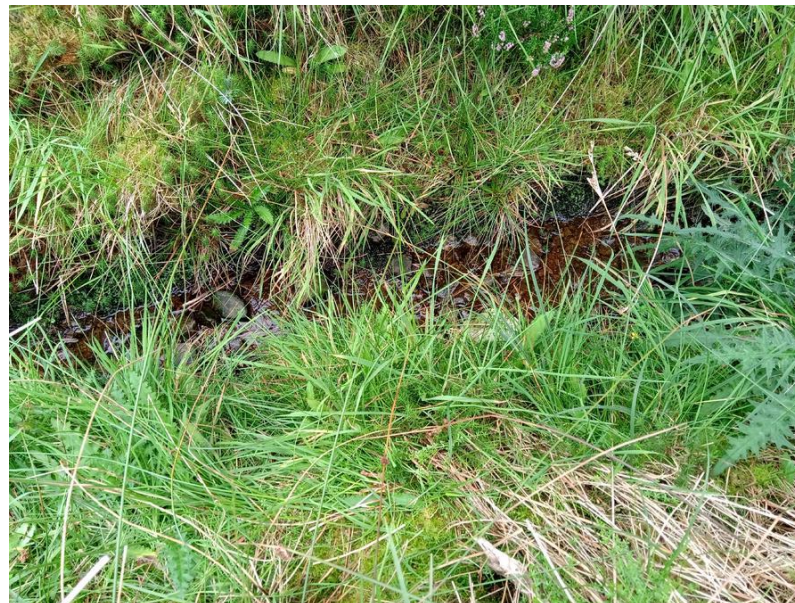
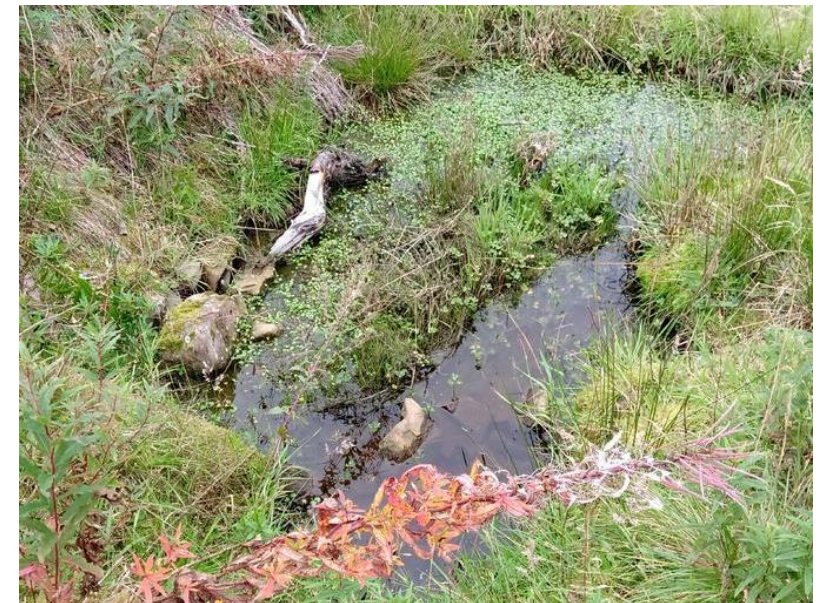
Table 8.1.9: Crossing WCX7

| WCX7 (300934,605513) | |
|---|--|
| <p>© Crown Copyright 2021. All rights reserved. Ordnance Survey Licence 0100031673.</p> | <p>Existing Crossing: Yes Crossing Type (existing): Circular Culvert Crossing Material (existing): Plastic Crossing Condition (existing): Good Channel Type: Incised, Poorly defined Gradient: Moderate Valley form: Shallow vee Bank condition: Stable Bed material: Coarse gravel, Boulders, Vegetation Riparian corridor: Commercial Forestry Flow condition: Slow</p> <p>Culvert Dimensions: 0.4 m Water width: 0.3 m Water depth: 0.1 m Bankfull width: 0.4 m Bankfull height: 0.2 m Banktop height: 0.7 m Flooded Bankfull width: 0.9 m Flooded Bankfull height: 0.4 m</p> <p>Notes: Measurements taken above culvert. Downstream photo taken below culvert.</p> <p>CAR Auth Level: GBR Proposed Crossing Type: Circular Culvert</p> |

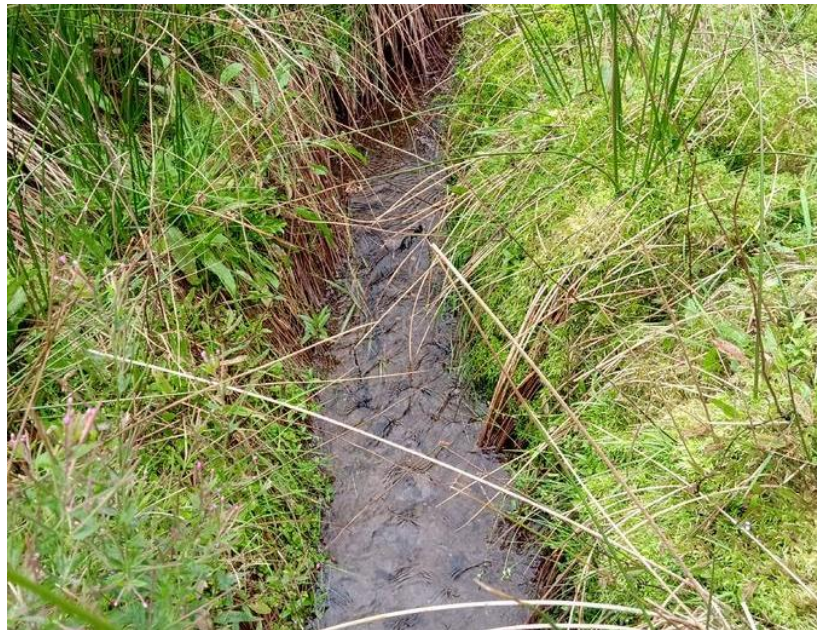
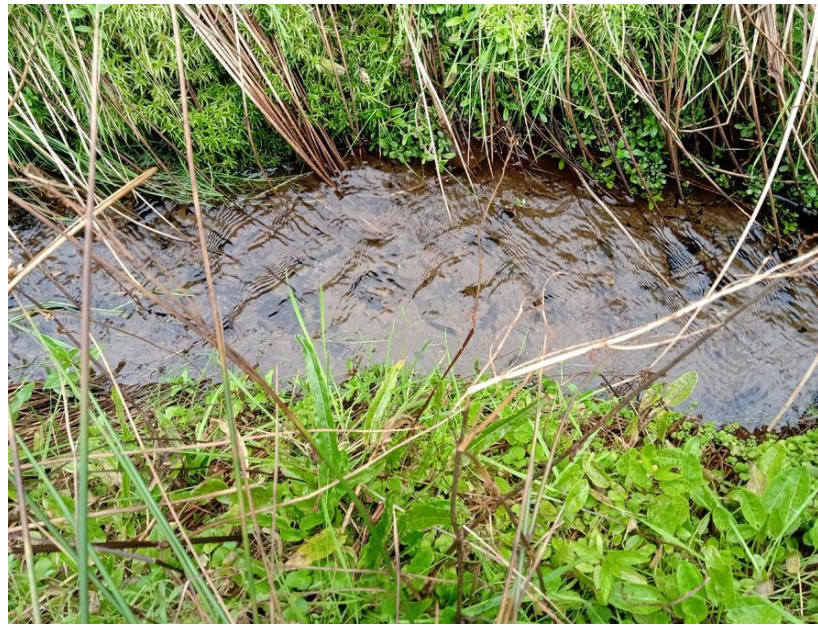
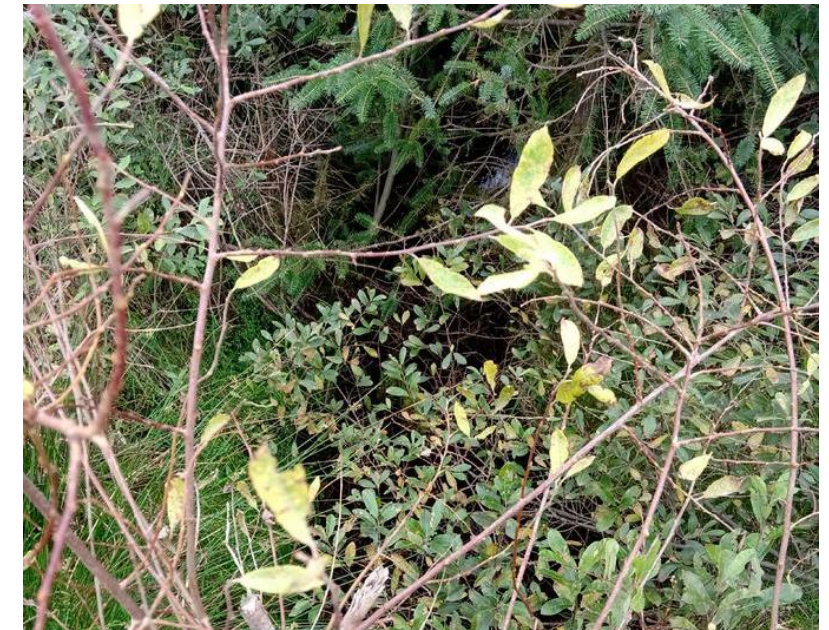
| WCX9 (302031,605227) | |
|---|---|
| <p>© Crown Copyright 2020. All rights reserved. Ordnance Survey Licence 0100031673.</p> | <p>Existing Crossing: Yes Crossing Type (existing): Circular Culvert Crossing Material (existing): Concrete Crossing Condition (existing): Good Channel Type: Poorly defined, Incised Gradient: Gentle Valley form: Shallow vee Bank condition: Stable Bed material: Fine sand/silt, Coarse gravel, Vegetation Riparian corridor: Commercial Forestry Flow condition: Moderate</p> <p>Culvert Dimensions: 0.4 m Water width: 0.3 m Water depth: 0.1 m Bankfull width: 0.45 m Bankfull height: 0.20 m Flooded Bankfull width: 0.9 m Flooded Bankfull height: 0.4 m</p> <p>Notes: None.</p> <p>CAR Auth Level: GBR Proposed Crossing Type: Circular Culvert</p> |

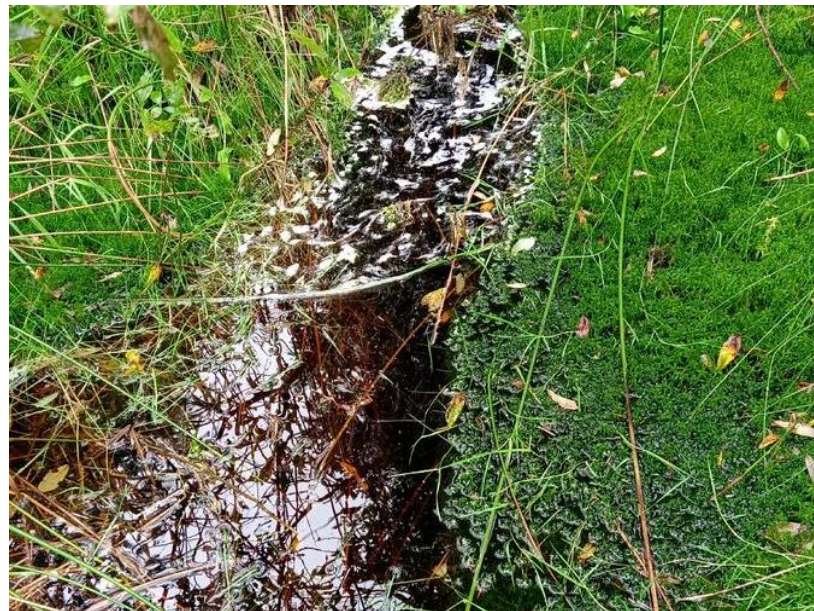
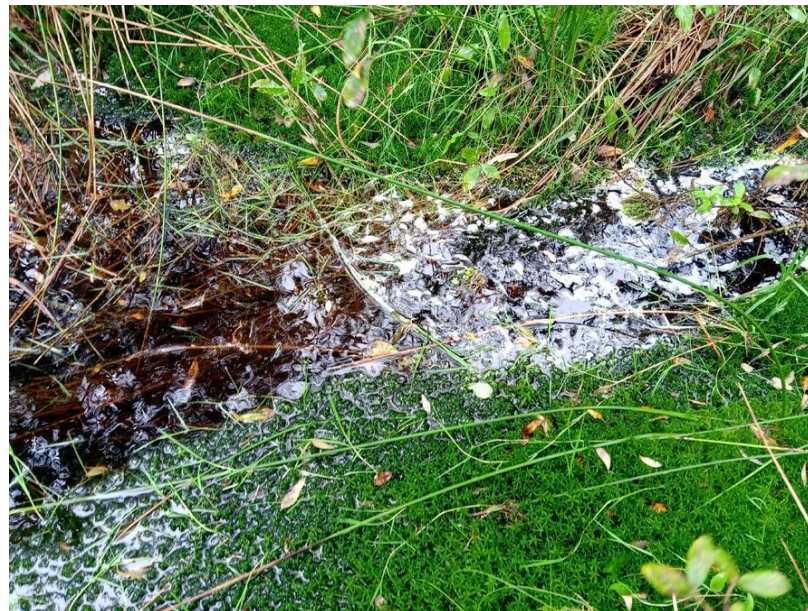
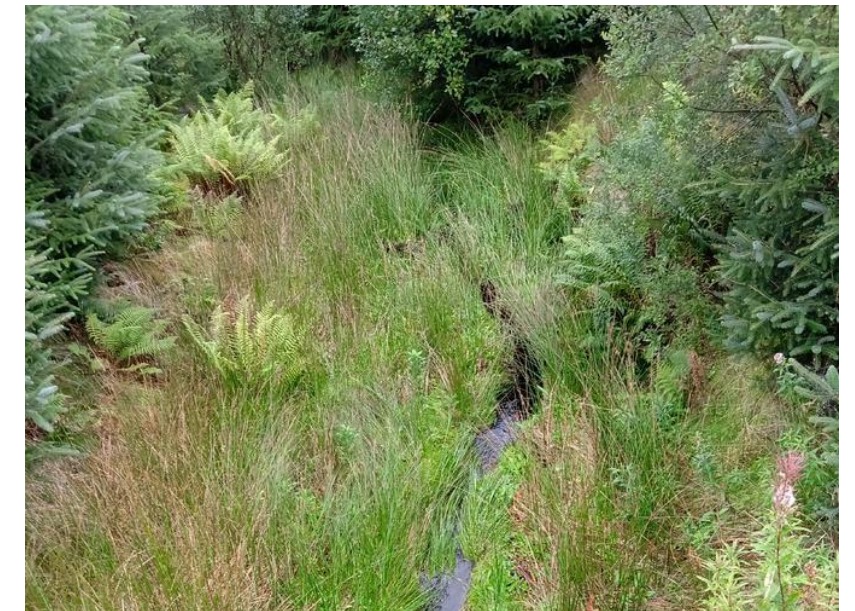
Table 8.1.82: Crossing WCX10

| WCX10 (302474,604611) | |
|---|---|
| <p>© Crown Copyright 2021. All rights reserved. Ordnance Survey Licence 0100031673.</p> | <p>Existing Crossing: No</p> <p>Channel Type: Poorly defined</p> <p>Gradient: Gentle</p> <p>Valley form: No obvious valley sides</p> <p>Bank condition: Stable</p> <p>Bed material: Vegetation, Rounded pebbles</p> <p>Riparian corridor: Commercial Forestry</p> <p>Flow condition: Moderate</p> <p>Water width: 0.25 m</p> <p>Water depth: 0.3 m</p> <p>Bankfull width: 0.5 m</p> <p>Bankfull height: 0.4 m</p> <p>Flooded Bankfull width: 1.8 m</p> <p>Flooded Bankfull height: 0.5 m</p> <p>Notes: None.</p> <p>CAR Auth Level: Registration</p> <p>Proposed Crossing Type: Circular Culvert</p> |

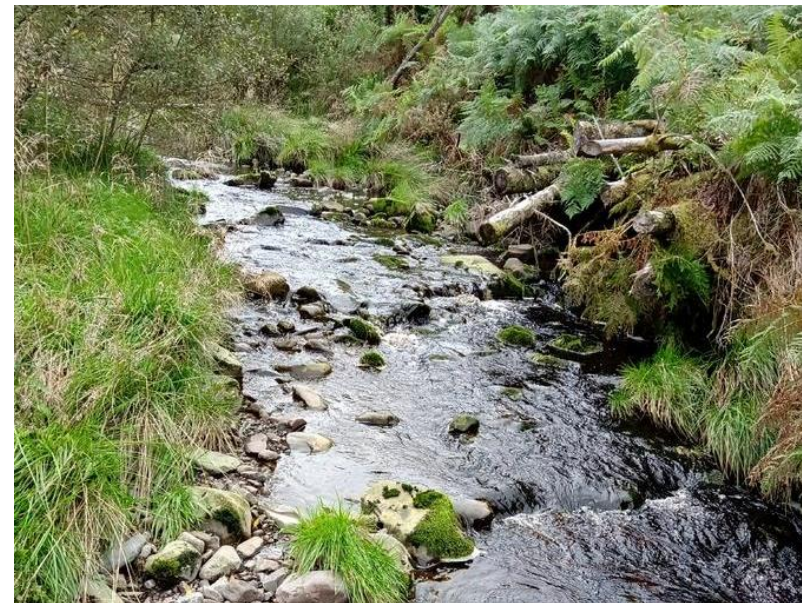
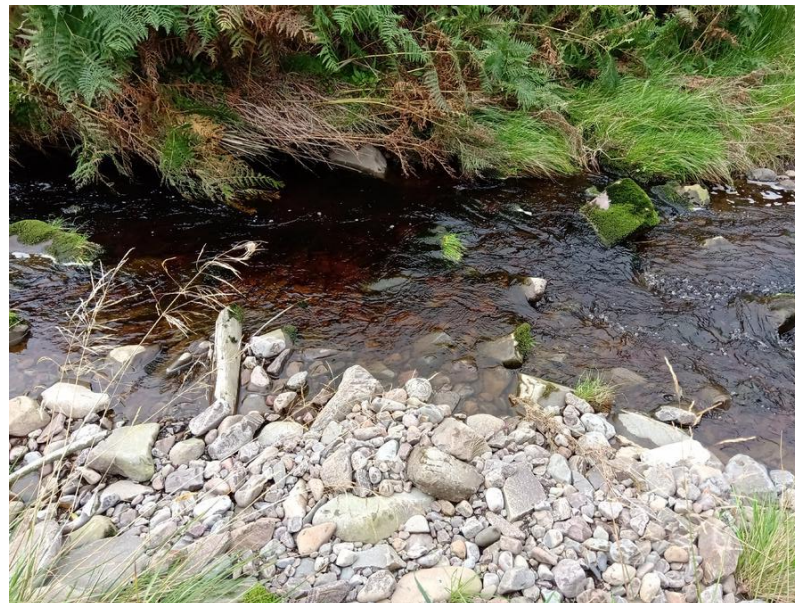
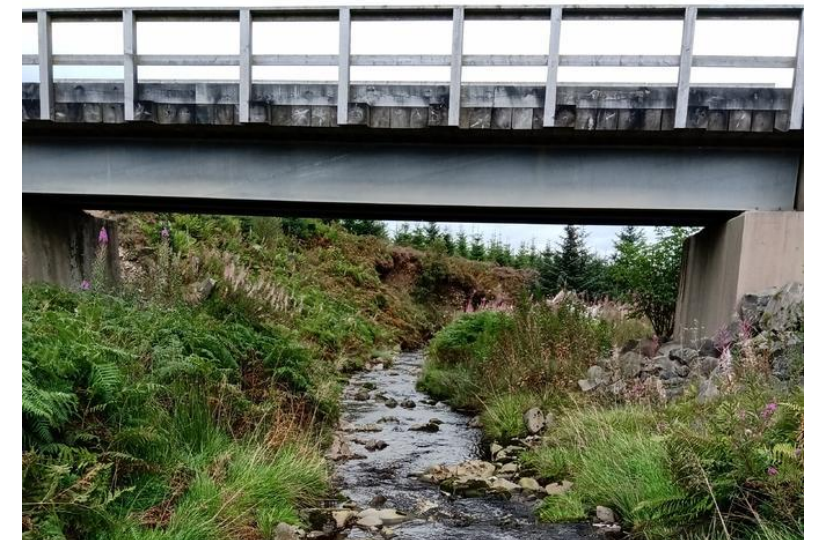
Table 8.1.13: Crossing WCX11

| WCX11 (302734,604543) | |
|---|--|
| <p>© Crown Copyright 2021. All rights reserved. Ordnance Survey Licence 0100031673.</p> | <p>Existing Crossing: Yes</p> <p>Crossing Type (existing): Bridge (no in channel support)</p> <p>Crossing Material (existing): Concrete, metal, timber</p> <p>Crossing Condition (existing): Excellent</p> <p>Channel Type: Incised</p> <p>Gradient: Moderate</p> <p>Valley form: Deep vee</p> <p>Bank condition: Stable</p> <p>Bed material: Rounded pebbles, Coarse gravel, Boulders, Bedrock</p> <p>Riparian corridor: Commercial Forestry</p> <p>Flow condition: Moderate</p> <p>Water width: 2.2 m</p> <p>Water depth: 0.3 m</p> <p>Bankfull width: 3.3 m</p> <p>Bankfull height: 0.30 m</p> <p>Banktop height: 2.4 m</p> <p>Flooded Bankfull width: 4.3 m</p> <p>Flooded Bankfull height: 0.65 m</p> <p>Notes: No in-stream abutments. Concrete abutments set back ~1 m from banks</p> <p>CAR Auth Level: No upgrade anticipated. Any minor works compliant with GBR9.</p> <p>Proposed Crossing Type: Existing Bridge</p> |

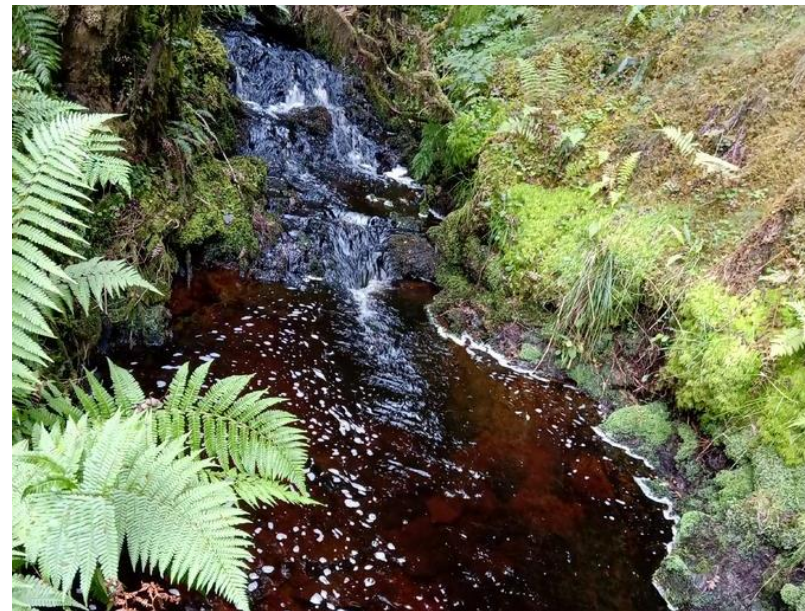
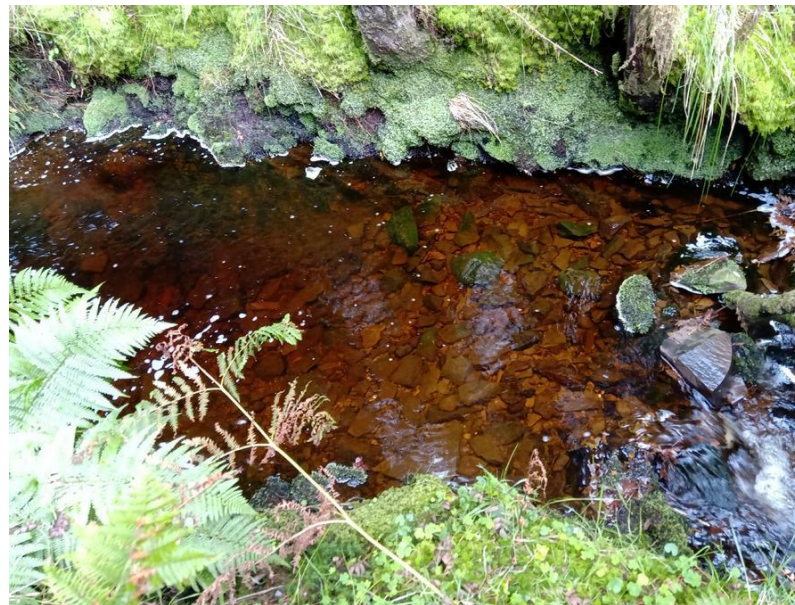
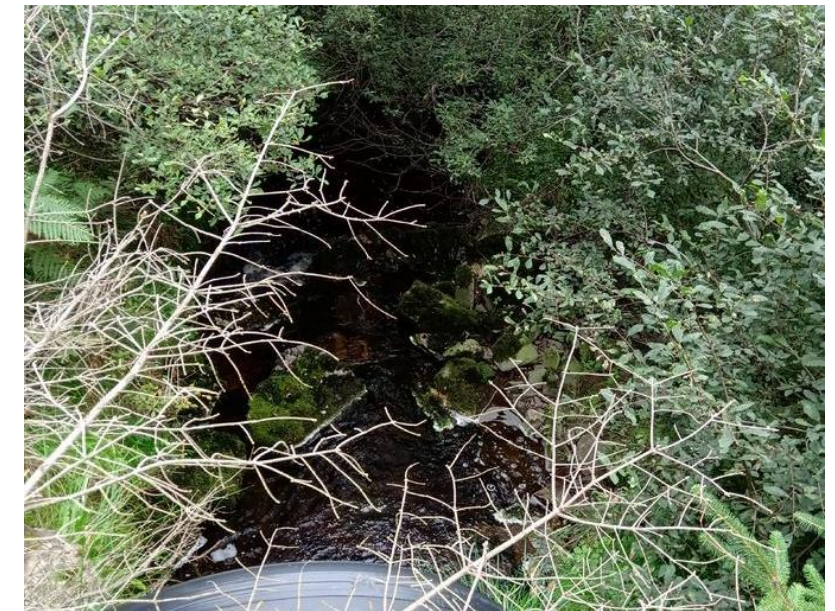
Table 8.1.14: Crossing WCX12

| WCX12 (303790,603715) | |
|---|--|
| <p>© Crown Copyright 2020. All rights reserved. Ordnance Survey Licence 0100031673.</p> | <p>Existing Crossing: Yes Crossing Type (existing): Circular Culvert Crossing Material (existing): Plastic Crossing Condition (existing): Good Channel Type: Incised Gradient: Moderate Valley form: Deep vee Bank condition: Stable Bed material: Coarse gravel, Boulders Riparian corridor: Commercial Forestry Flow condition: Moderate</p> <p>Culvert Dimensions: 1.2 m Water width: 1.3 m Water depth: 0.35 m Bankfull width: 1.3 m Bankfull height: 1.15 m Flooded Bankfull width: 2.3 m Flooded Bankfull height: 1.4 m</p> <p>Notes: None.</p> <p>CAR Auth Level: Registration Proposed Crossing Type: Circular Culvert</p> |

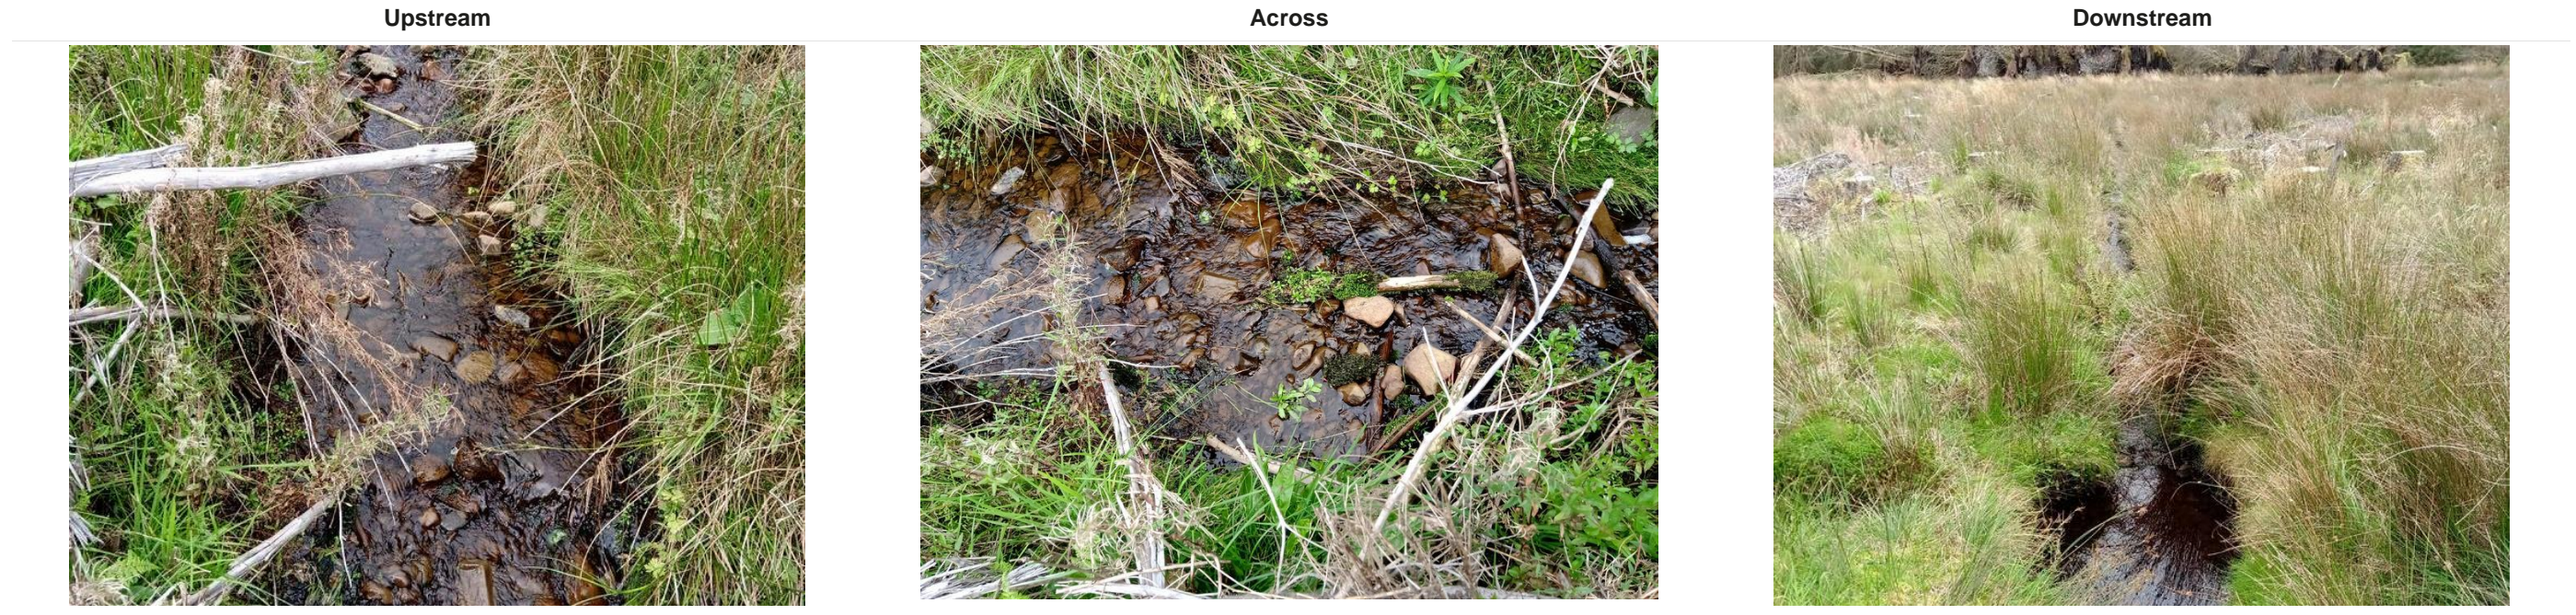
Table 8.1.15: Crossing WCX13

| WCX13 (303866,602554) | |
|---|---|
| <p>© Crown Copyright 2020. All rights reserved. Ordnance Survey Licence 0100031673.</p> | <p>Existing Crossing: Yes Crossing Type (existing): Circular Culvert Crossing Material (existing): Plastic Crossing Condition (existing): Good Channel Type: Poorly defined, Incised Gradient: Moderate Valley form: No obvious valley sides, Shallow vee Bank condition: Stable Bed material: Fine sand/silt, Rounded pebbles, Coarse gravel, Boulders, Vegetation Riparian corridor: Commercial Forestry Flow condition: Moderate</p> <p>Culvert Dimensions: 0.5 m Water width: 0.6 m Water depth: 0.1 m Bankfull width: 1 m Bankfull height: 0.4 m Flooded Bankfull width: 1.3 m Flooded Bankfull height: 0.7 m</p> <p>Notes: None.</p> <p>CAR Auth Level: Registration Proposed Crossing Type: Circular Culvert</p> |

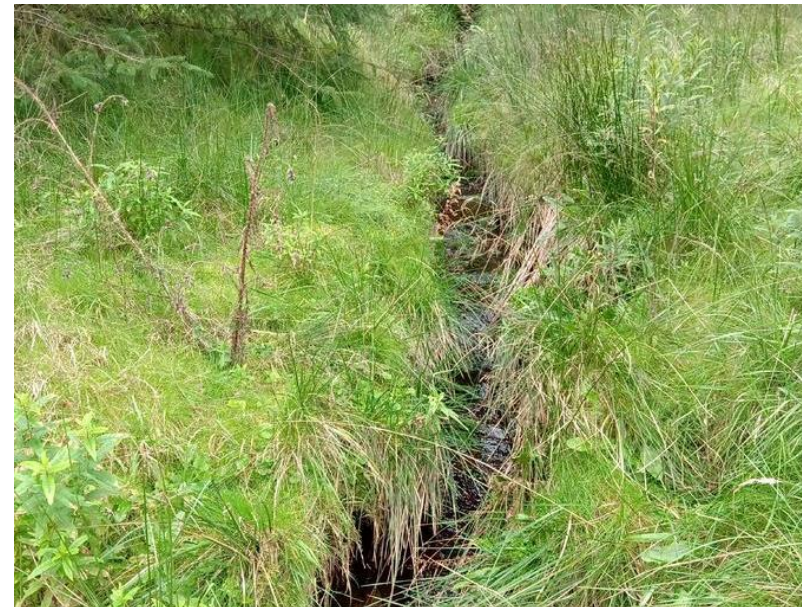
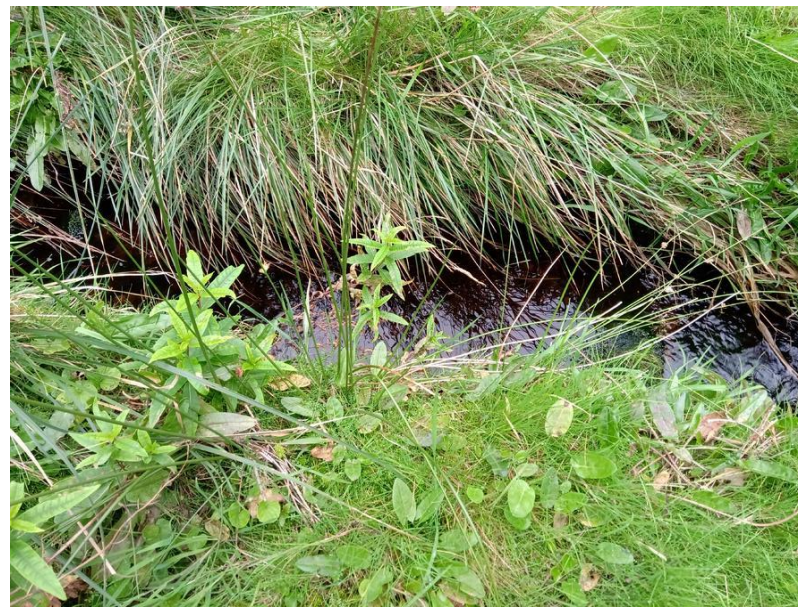
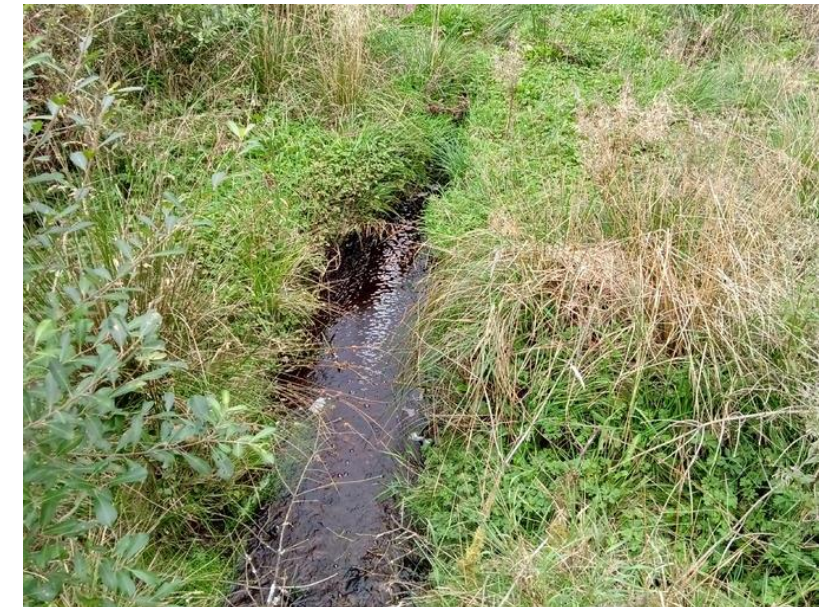
Table 8.1.9: Crossing WCX14

| WCX14 (303780,602422) | |
|---|---|
| <p>© Crown Copyright 2020. All rights reserved. Ordnance Survey Licence 0100031673.</p> | <p>Existing Crossing: Yes Crossing Type (existing): Circular Culvert Crossing Material (existing): Plastic Crossing Condition (existing): Good Channel Type: Incised Gradient: Moderate Valley form: Shallow vee Bank condition: Stable Bed material: Coarse gravel, Boulders, Vegetation Riparian corridor: Commercial Forestry Flow condition: Moderate</p> <p>Culvert Dimensions: 0.8 m Water width: 0.55 m Water depth: 0.12 m Bankfull width: 0.55 m Bankfull height: 0.46 m Flooded Bankfull width: 3.8 m Flooded Bankfull height: 0.7 m</p> <p>Notes: None.</p> <p>CAR Auth Level: Registration Proposed Crossing Type: Circular Culvert</p> |
