Appendix 8.1

Watercourse Crossing Assessment

This document details the requirements for a Watercourse Crossings Assessment at Daer Wind Farm (the proposed development) as part of Chapter 8 of the Environmental Impact Assessment Report (EIAR). The purpose of this document is to provide the relevant information associated with the watercourse crossings required as part of the proposed development and to assist in the identification of regulatory licensing requirements. It is recommended that all the watercourse crossings are designed to maintain hydrology as well as, where necessary, allowing the free passage of mammals and aquatic species.

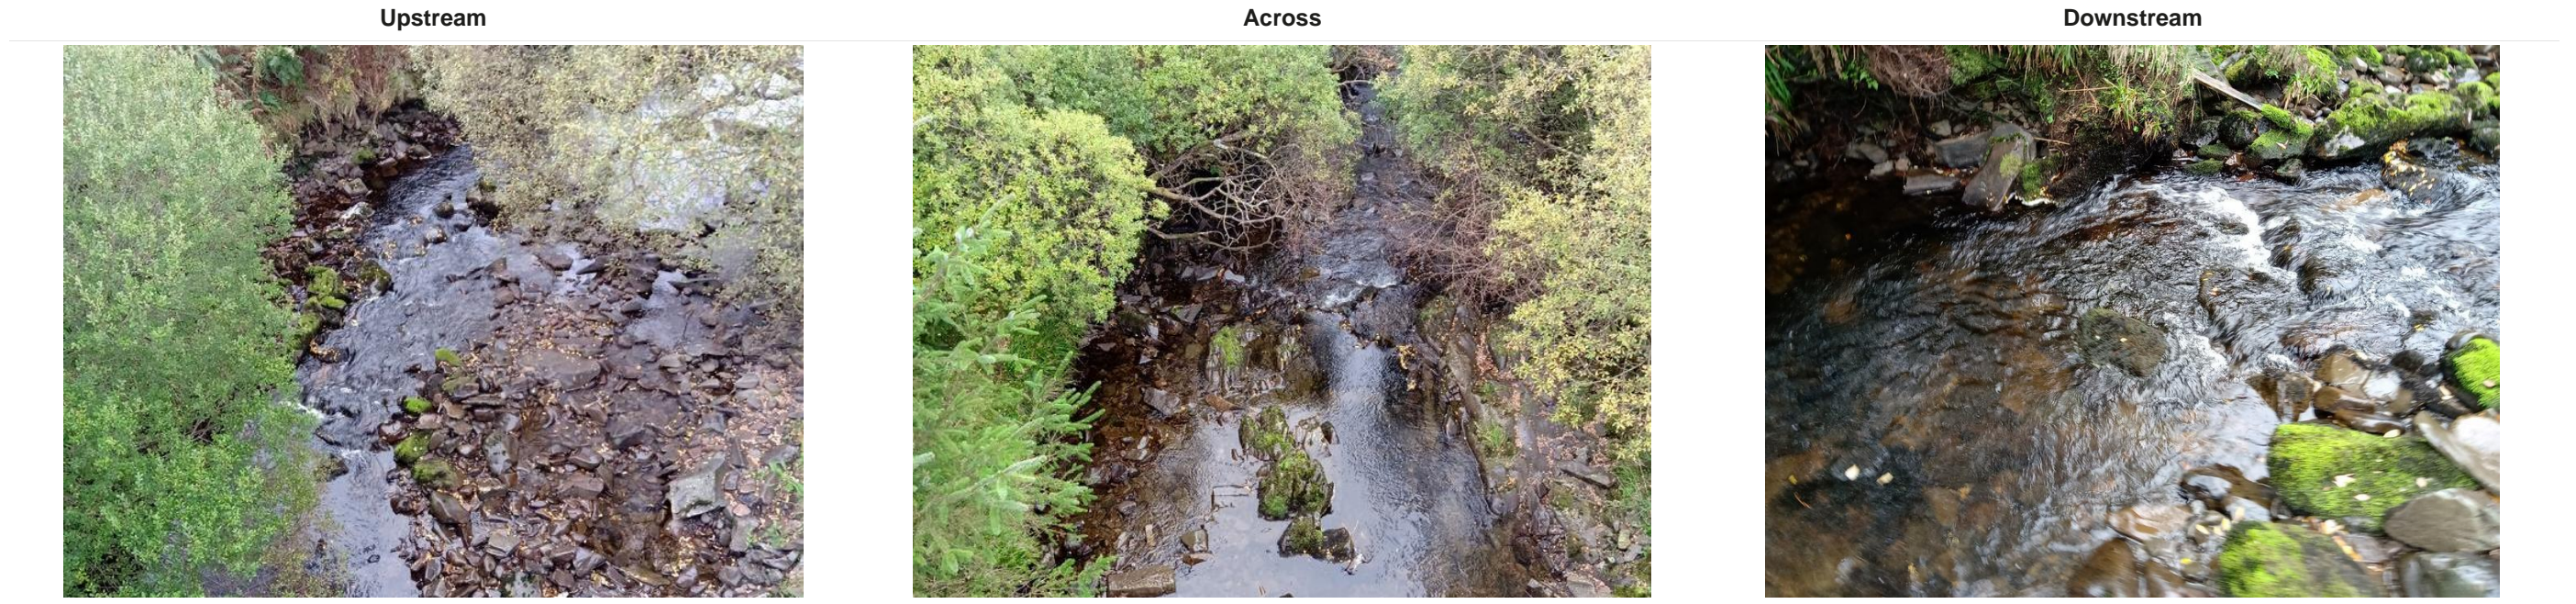
Table 8.1.10: Crossing WCX15

| WCX15 (304039,601249) | |
|---|--|
| <p>© Crown Copyright 2020. All rights reserved. Ordnance Survey Licence 0100031673.</p> | <p>Existing Crossing: Yes</p> <p>Crossing Type (existing): Bridge (no in channel support)</p> <p>Crossing Material (existing): Concrete, metal, timber</p> <p>Crossing Condition (existing): Good</p> <p>Channel Type: Incised, Meandering, Broad</p> <p>Gradient: Gentle</p> <p>Valley form: Shallow vee</p> <p>Bank condition: Stable</p> <p>Bed material: Fine sand/silt, Coarse gravel, Boulders, Bedrock</p> <p>Riparian corridor: Commercial Forestry, Natural Woodland</p> <p>Flow condition: Moderate</p> <p>Water width: 2.5 m</p> <p>Water depth: 0.4 m</p> <p>Bankfull width: 4 m</p> <p>Bankfull height: 0.5 m</p> <p>Banktop height: 2 m</p> <p>Flooded Bankfull width: 5 m</p> <p>Flooded Bankfull height: 0.7 m</p> <p>Notes: None.</p> <p>CAR Auth Level: No upgrade anticipated. Any minor works compliant with GBR9.</p> <p>Proposed Crossing Type: Existing Bridge</p> |

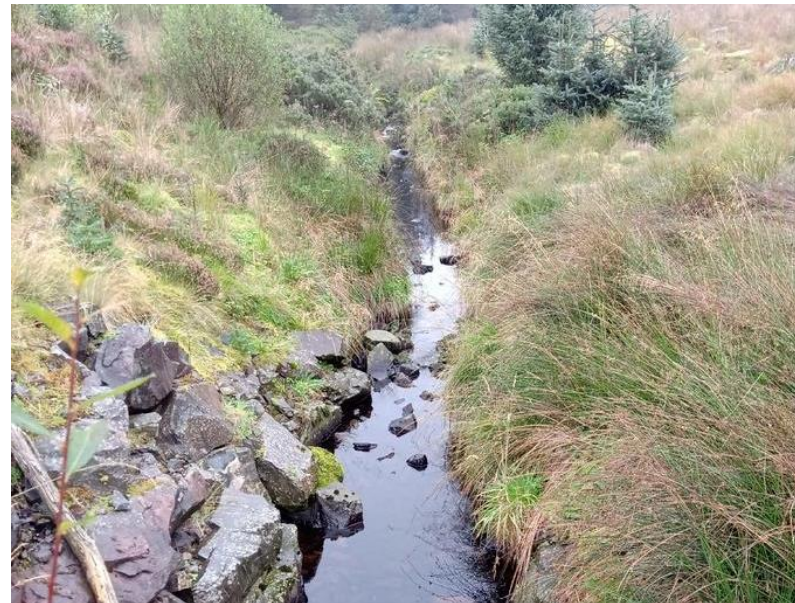
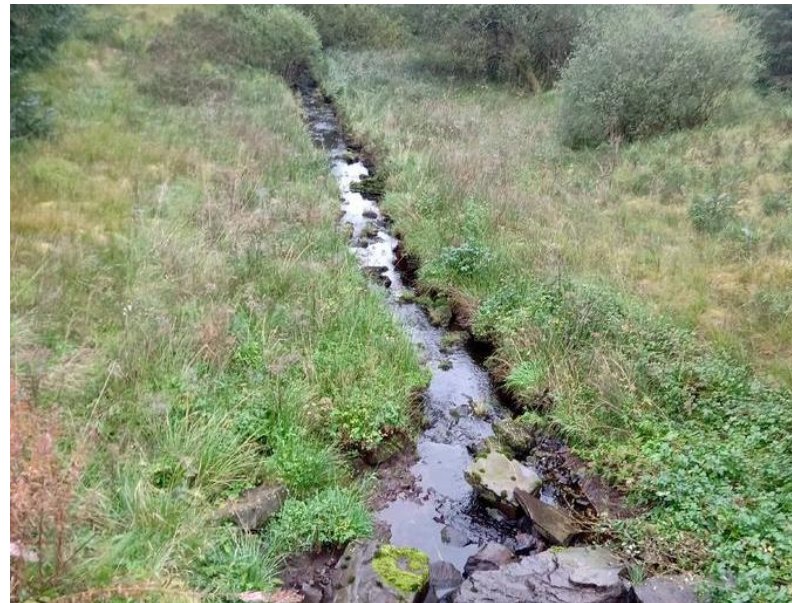
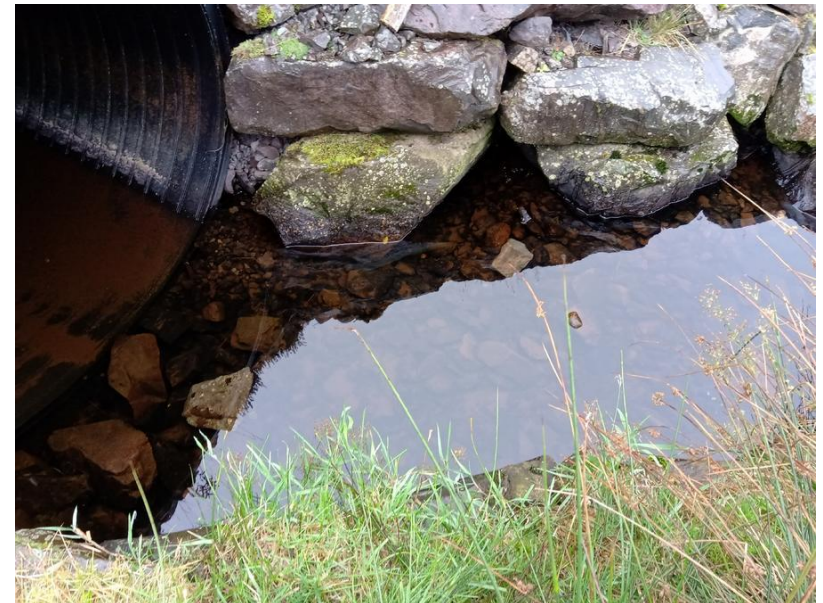
Table 8.1.11: Crossing WCX16

| WCX16 (303386,600803) | |
|---|---|
| <p>© Crown Copyright 2020. All rights reserved. Ordnance Survey Licence 0100031673.</p> | <p>Existing Crossing: Yes Crossing Type (existing): Circular Culvert Crossing Material (existing): Plastic Crossing Condition (existing): Good Channel Type: Poorly defined, Incised Gradient: Gentle Valley form: Shallow vee Bank condition: Stable Bed material: Coarse gravel, Boulders, Rounded pebbles, Fine sand/silt Riparian corridor: Commercial Forestry Flow condition: Moderate</p> <p>Culvert Dimensions: 2 m Water width: 1.4 m Water depth: 0.25 m Bankfull width: 1.4 m Bankfull height: 0.8 m Flooded Bankfull width: 2.4 m Flooded Bankfull height: 0.9 m</p> <p>Notes: None.</p> <p>CAR Auth Level: Registration Proposed Crossing Type: Circular Culvert</p> |

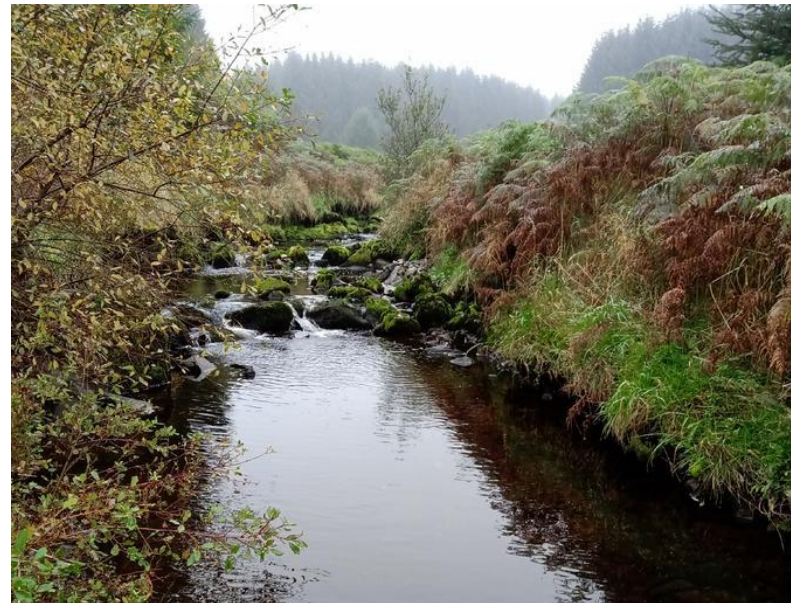
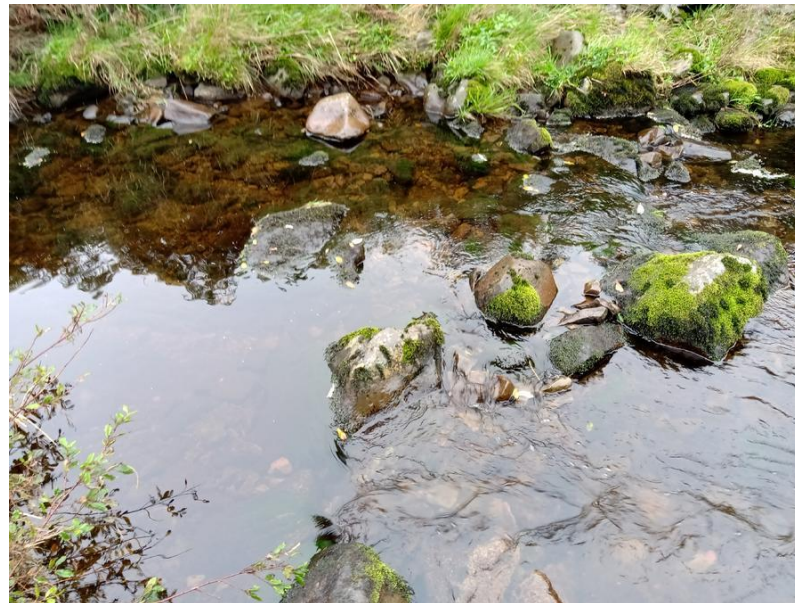
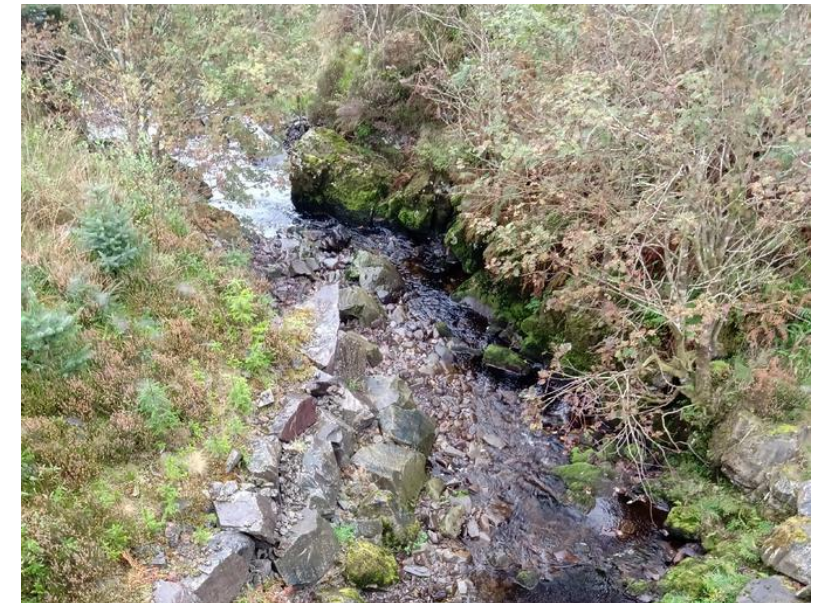
Table 8.1.129: Crossing WCX17

| WCX17 (302990,600314) | |
|---|--|
| <p>© Crown Copyright 2020. All rights reserved. Ordnance Survey Licence 0100031673.</p> | <p>Existing Crossing: Yes Crossing Type (existing): Bridge (no in channel support) Crossing Material (existing): Metal, concrete and timber Crossing Condition (existing): Good Channel Type: Incised, Meandering Gradient: Gentle Valley form: Shallow vee Bank condition: Stable Bed material: Fine sand/silt, Coarse gravel, Bedrock & Boulders Riparian corridor: Commercial Forestry Flow condition: Moderate</p> <p>Water width: 3 m Water depth: 0.35 m Bankfull width: 3.5 m Bankfull height: 0.4 m Flooded Bankfull width: 4.8 m Flooded Bankfull height: 0.8 m</p> <p>Notes: None.</p> <p>CAR Auth Level: No upgrade anticipated. Any minor works compliant with GBR9. Proposed Crossing Type: Existing Bridge</p> |

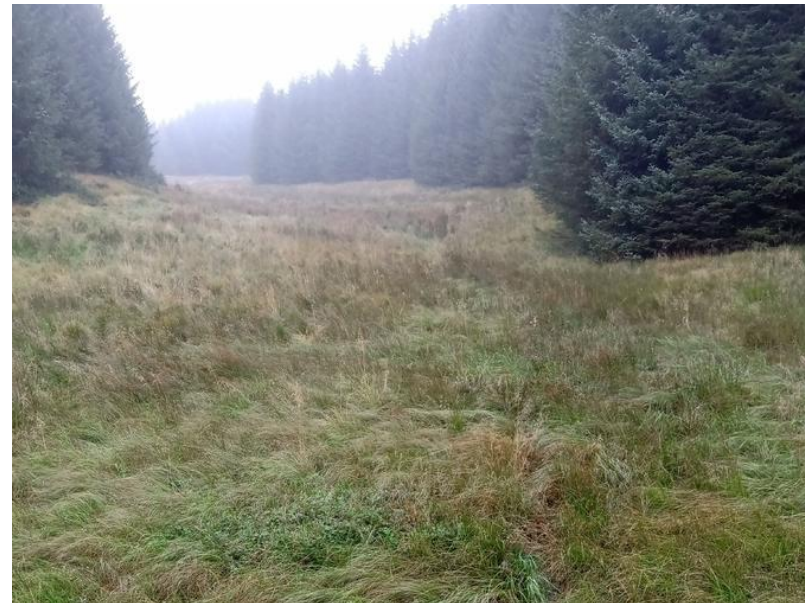
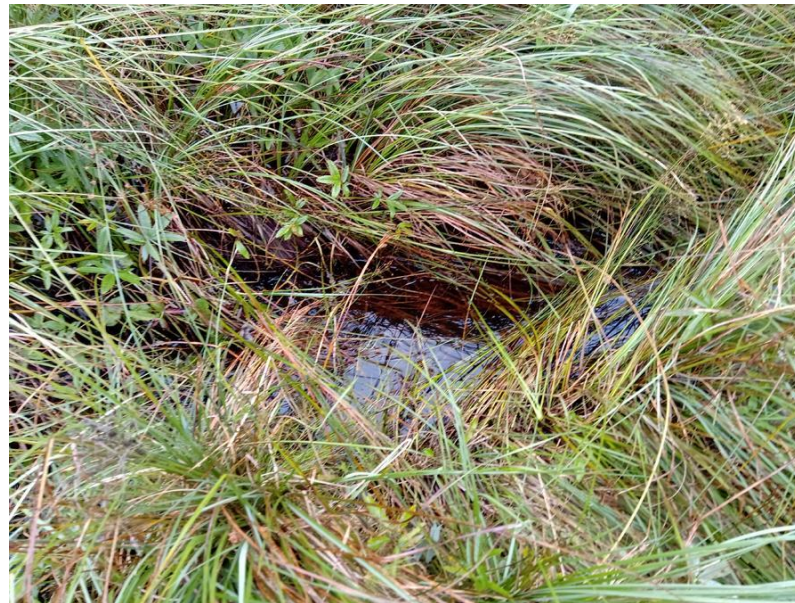
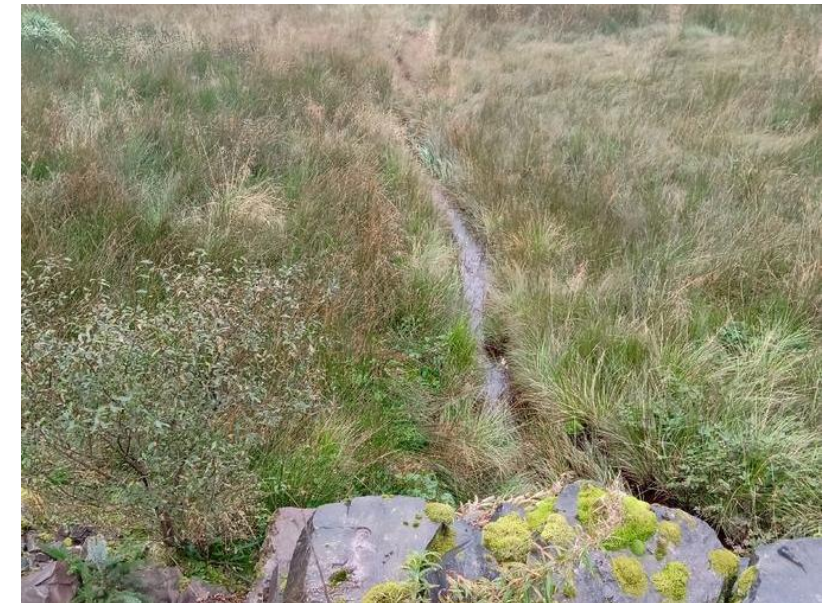
Table 8.1.20: Crossing WCX18

| WCX18 (303673,598424) | |
|---|--|
| <p>© Crown Copyright 2020. All rights reserved. Ordnance Survey Licence 0100031673.</p> | <p>Existing Crossing: Yes Crossing Type (existing): Circular Culvert Crossing Material (existing): Plastic Crossing Condition (existing): Good Channel Type: None evident, Poorly defined Gradient: Gentle Valley form: No obvious valley sides Bank condition: Stable Bed material: Vegetation Riparian corridor: Heavily Vegetated, Commercial Forestry Flow condition: Slow</p> <p>Culvert Dimensions: 1.1 m Water width: 0.65 m Water depth: 0.33 m Bankfull width: 2.65 m Bankfull height: 0.4 m Flooded Bankfull width: 4-6 m Flooded Bankfull height: 0.5-0.75 m</p> <p>Notes: None.</p> <p>CAR Auth Level: Registration Proposed Crossing Type: Circular Culvert</p> |

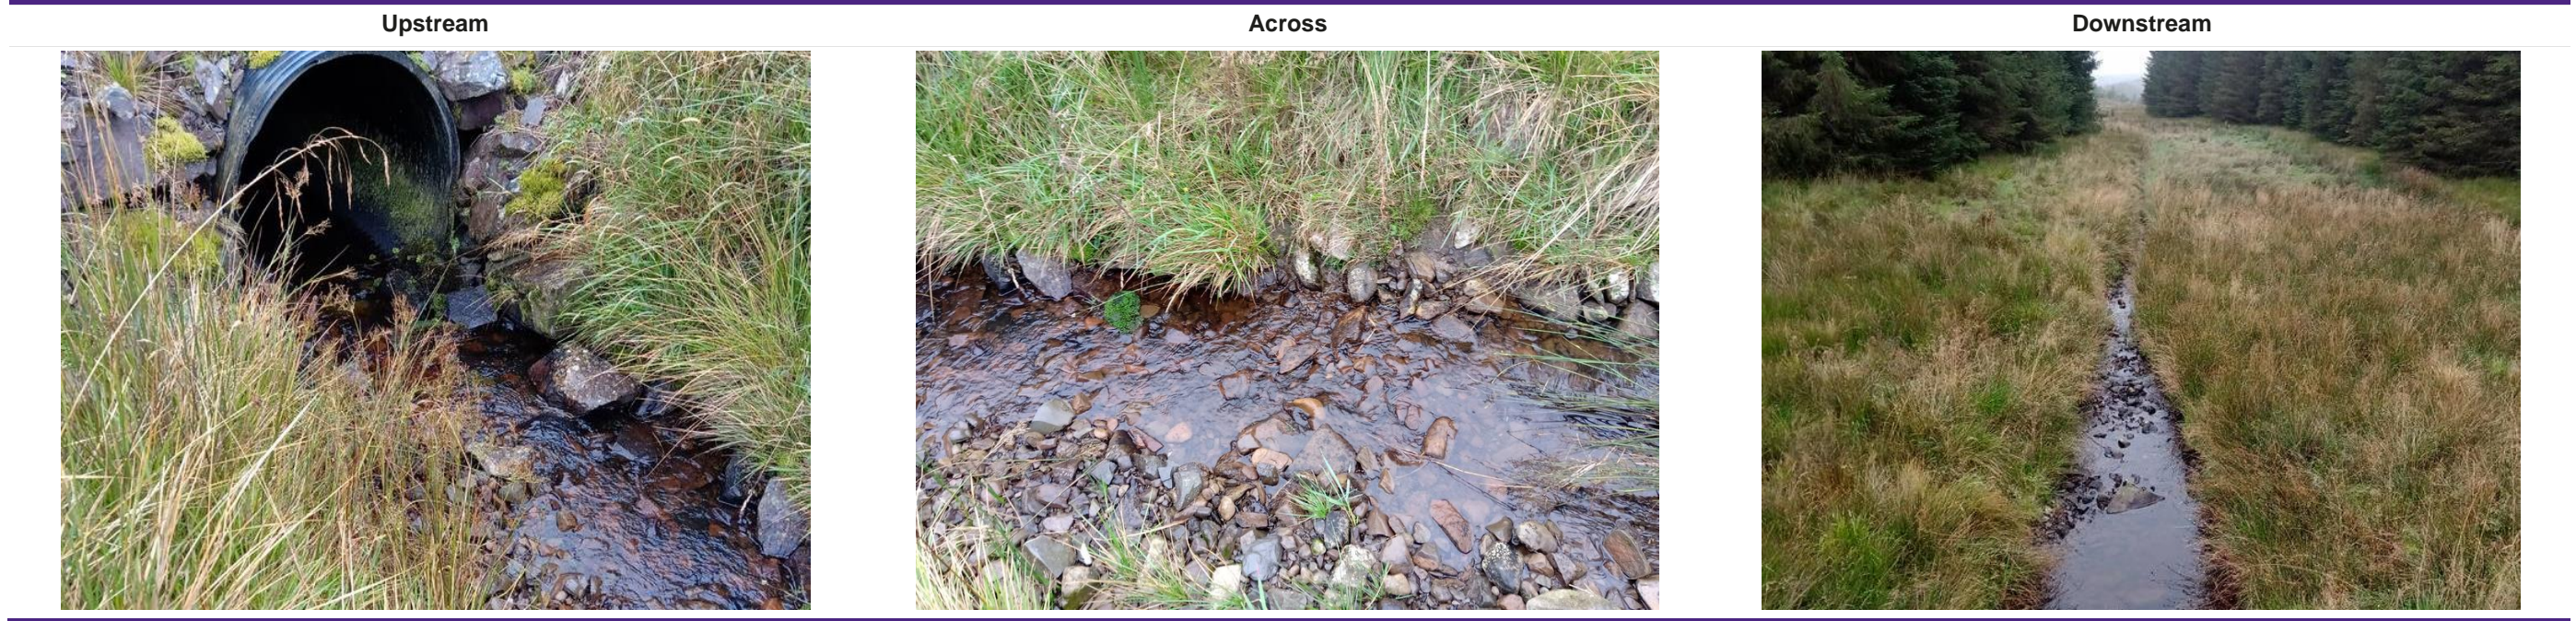
Table 8.1.13: Crossing WCX19

| WCX19 (304669,597349) | |
|---|---|
| <p>© Crown Copyright 2020. All rights reserved. Ordnance Survey Licence 0100031673.</p> | <p>Existing Crossing: Yes</p> <p>Crossing Type (existing): Circular Culvert</p> <p>Crossing Material (existing): Plastic</p> <p>Crossing Condition (existing): Good</p> <p>Channel Type: Poorly defined, Incised</p> <p>Gradient: Gentle</p> <p>Valley form: No obvious valley sides, Shallow vee</p> <p>Bank condition: Stable</p> <p>Bed material: Fine sand/silt, Rounded pebbles, Coarse gravel, Boulders, Vegetation</p> <p>Riparian corridor: Moorland, Commercial Forestry</p> <p>Flow condition: Moderate</p> <p>Culvert Dimensions: 0.9 m</p> <p>Water width: 1 m</p> <p>Water depth: 0.1 m</p> <p>Bankfull width: 1 m</p> <p>Bankfull height: 0.35 m</p> <p>Flooded Bankfull width: 1.5 m</p> <p>Flooded Bankfull height: 0.45 m</p> <p>Notes: None.</p> <p>CAR Auth Level: Registration</p> <p>Proposed Crossing Type: Circular Culvert</p> |

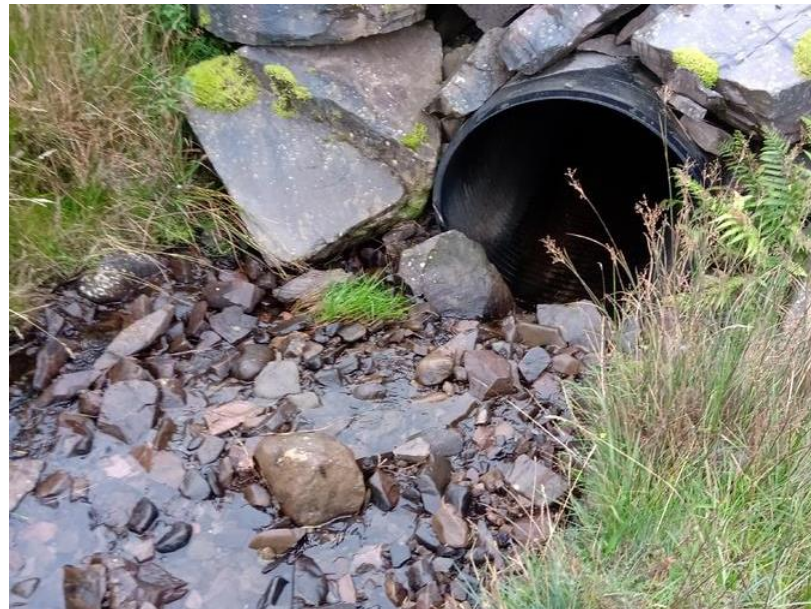
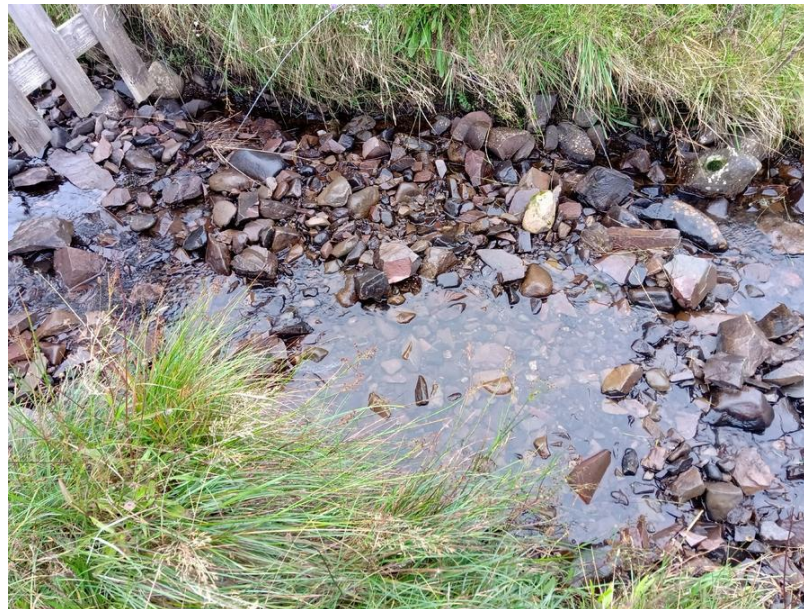
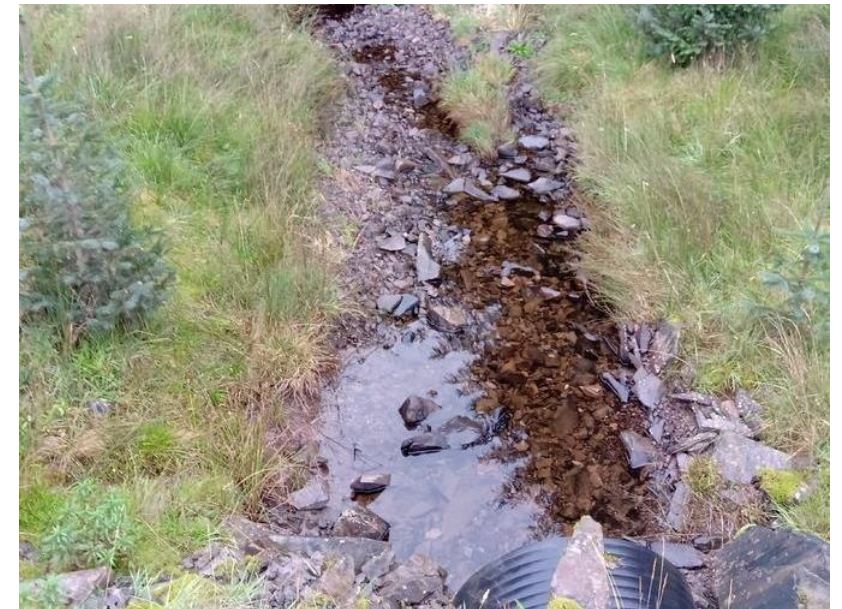
Table 8.1.14: Crossing WCX20

| WCX20 (305026,597369) | |
|---|---|
| <p>© Crown Copyright 2020. All rights reserved. Ordnance Survey Licence 0100031673.</p> | <p>Existing Crossing: Yes Crossing Type (existing): Circular Culvert Crossing Material (existing): Plastic Crossing Condition (existing): Good Channel Type: Incised, Poorly defined Gradient: Gentle Valley form: Shallow vee Bank condition: Stable Bed material: Fine sand/silt, Rounded pebbles, Coarse gravel, Boulders Riparian corridor: Moorland, Commercial Forestry Flow condition: Moderate</p> <p>Culvert Dimensions: 0.95 m Water width: 0.9 m Water depth: 0.1 m Bankfull width: 1.5 m Bankfull height: 0.25 m Flooded Bankfull width: 2.5 m Flooded Bankfull height: 0.35 m</p> <p>Notes: None.</p> <p>CAR Auth Level: Registration Proposed Crossing Type: Circular Culvert</p> |

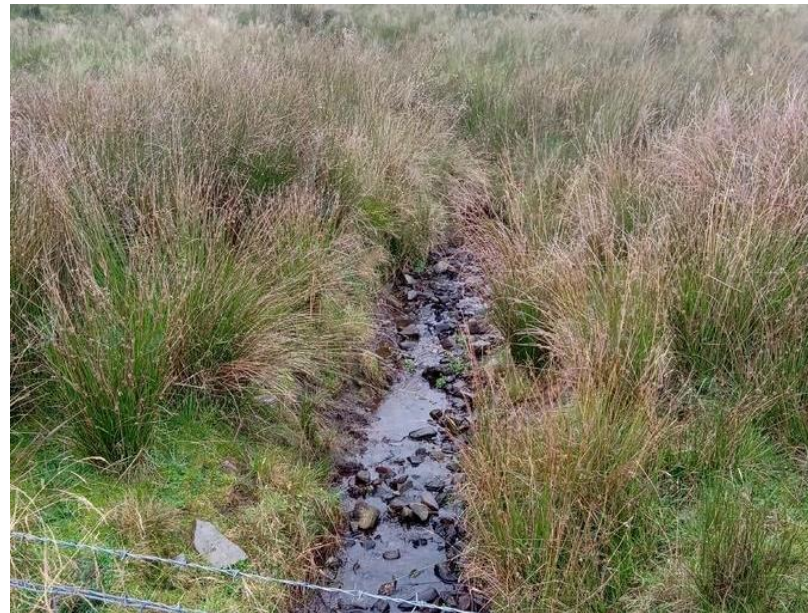
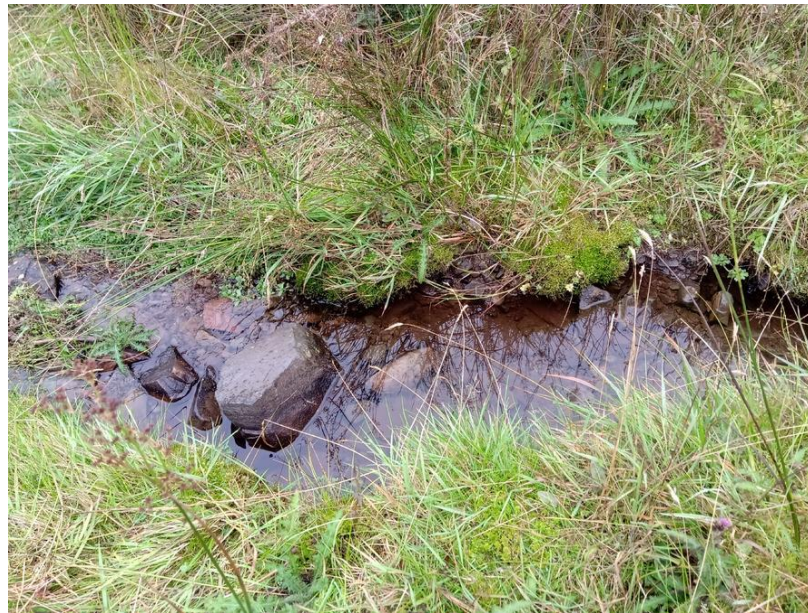
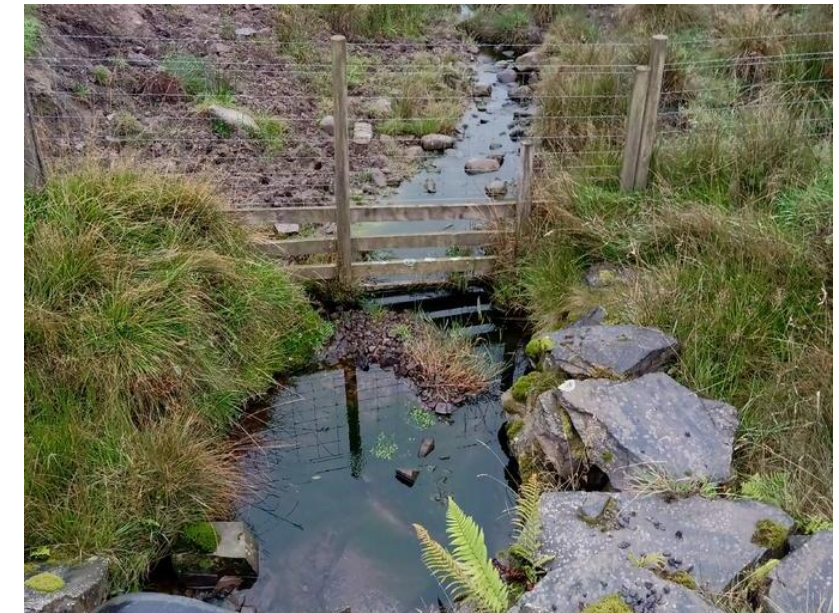
Table 8.1.15: Crossing WCX21

| WCX21 (305465,597696) | |
|---|---|
| <p>© Crown Copyright 2020. All rights reserved. Ordnance Survey Licence 0100031673.</p> | <p>Existing Crossing: Yes Crossing Type (existing): Circular Culvert Crossing Material (existing): Plastic Crossing Condition (existing): Average Channel Type: Poorly defined, Incised Gradient: Gentle Valley form: Shallow vee Bank condition: Stable Bed material: Fine sand/silt, Rounded pebbles, Coarse gravel, Boulders Riparian corridor: Moorland Flow condition: Moderate</p> <p>Culvert Dimensions: 0.9 m Water width: 0.46 m Water depth: 0.08 m Bankfull width: 0.5 m Bankfull height: 0.23 m Flooded Bankfull width: 1.5 m Flooded Bankfull height: 0.4 m</p> <p>Notes: None.</p> <p>CAR Auth Level: Registration Proposed Crossing Type: Circular Culvert</p> |

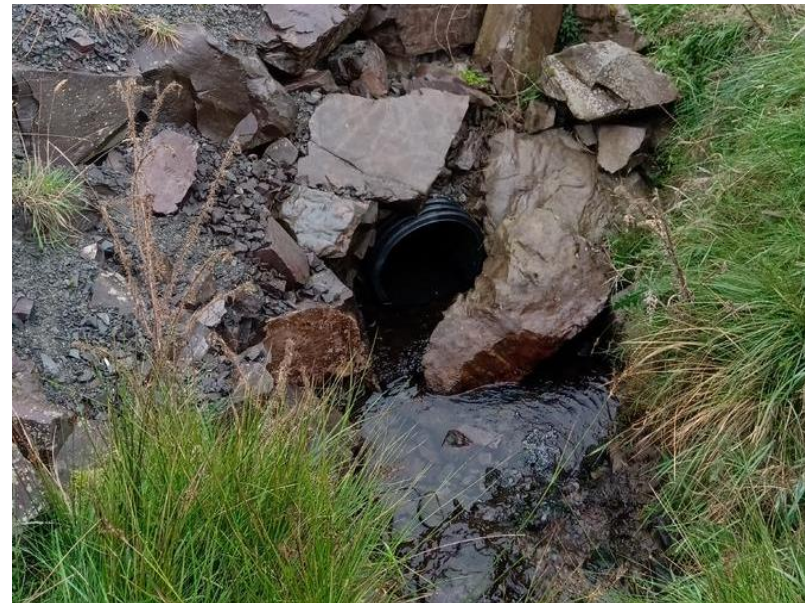
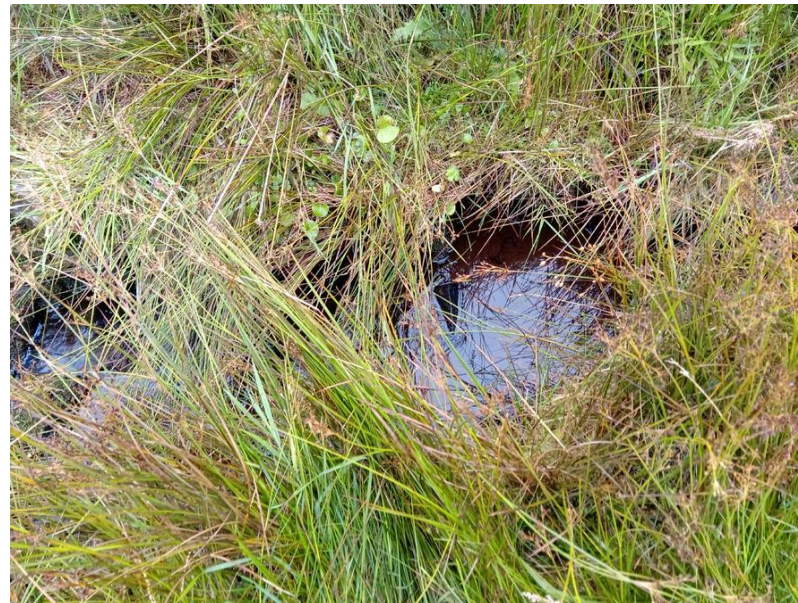
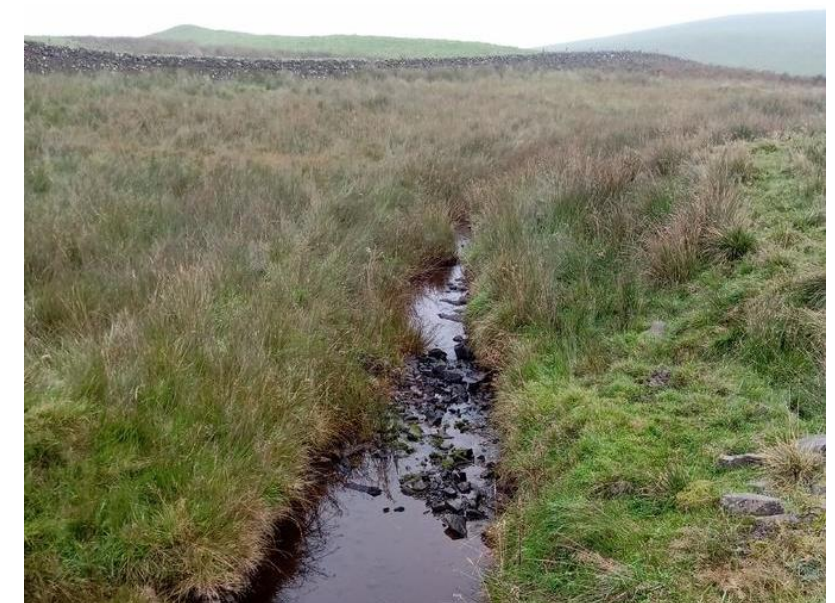
Table 8.1.16: Crossing WCX22

| WCX22 (306268,597916) | |
|---|--|
| <p>© Crown Copyright 2020. All rights reserved. Ordnance Survey Licence 0100031673.</p> | <p>Existing Crossing: Yes Crossing Type (existing): Circular Culvert Crossing Material (existing): Plastic Crossing Condition (existing): Average Channel Type: Poorly defined, Incised Gradient: Gentle Valley form: Shallow vee Bank condition: Stable Bed material: Coarse gravel, Boulders, Rounded pebbles Riparian corridor: Moorland Flow condition: Moderate</p> <p>Culvert Dimensions: 0.45 m Water width: 0.45 m Water depth: 0.09 m Bankfull width: 0.45 m Bankfull height: 0.2 m Flooded Bankfull width: 1 m Flooded Bankfull height: 0.5 m</p> <p>Notes: None.</p> <p>CAR Auth Level: Registration Proposed Crossing Type: Circular Culvert</p> |

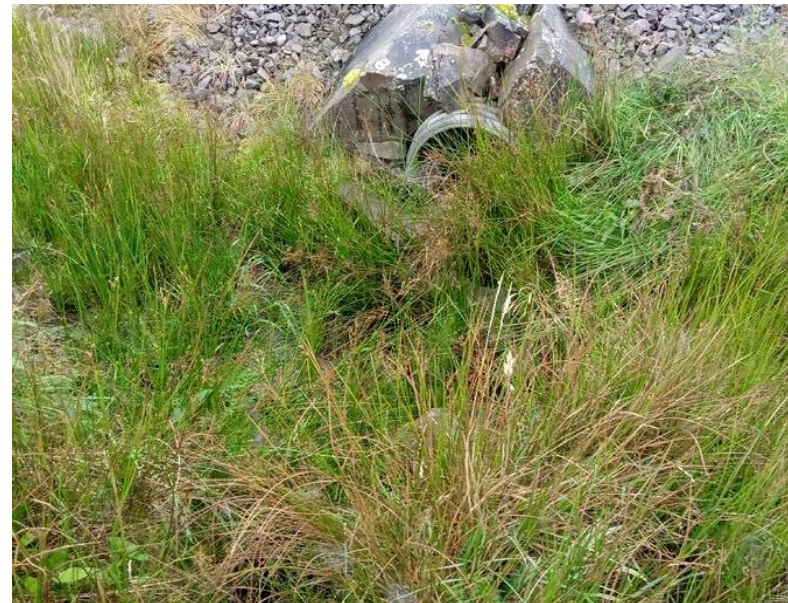
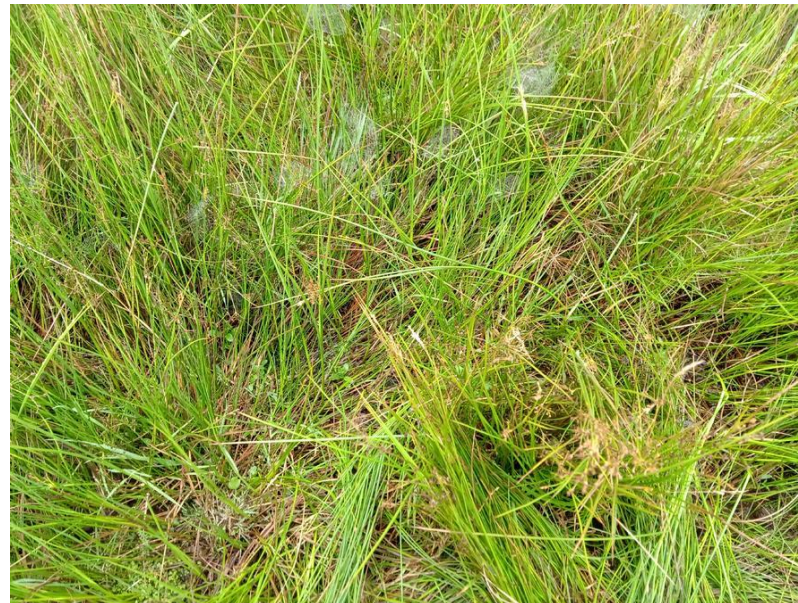
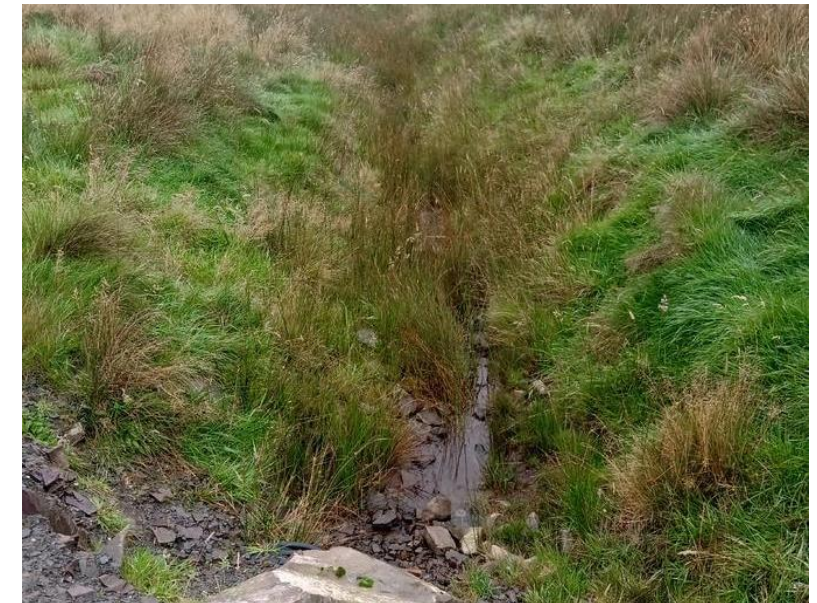
Table 8.1.17: Crossing WCX23

| WCX23 (306514,597865) | |
|---|---|
| <p>© Crown Copyright 2020. All rights reserved. Ordnance Survey Licence 0100031673.</p> | <p>Existing Crossing: Yes Crossing Type (existing): Circular Culvert Crossing Material (existing): Plastic Crossing Condition (existing): Average Channel Type: Poorly defined, Incised Gradient: Moderate Valley form: No obvious valley sides Bank condition: Stable Bed material: Vegetation Riparian corridor: Moorland Flow condition: Slow</p> <p>Culvert Dimensions: 0.45 m Water width: 0.25 m Water depth: 0.05 m Bankfull width: 0.7 m Bankfull height: 0.15 m Flooded Bankfull width: 2 m Flooded Bankfull height: 0.3 m</p> <p>Notes: None.</p> <p>CAR Auth Level: GBR Proposed Crossing Type: Circular Culvert</p> |

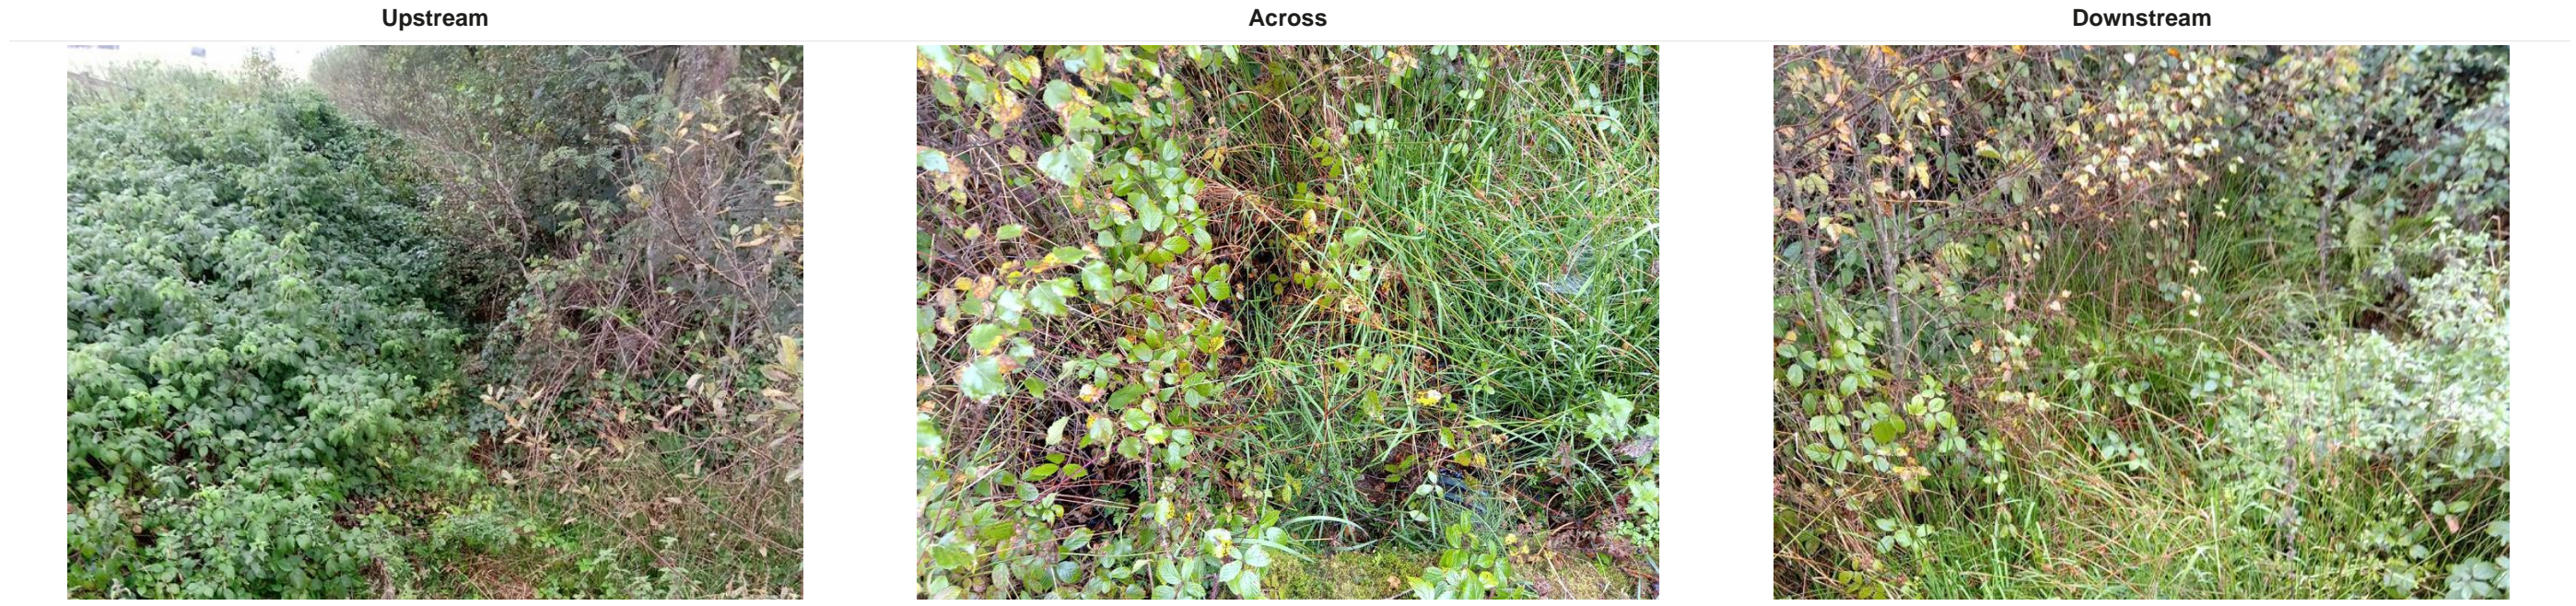
Table 8.1.186: Crossing WCX24

| WCX24 (306911,598063) | |
|---|--|
| <p>© Crown Copyright 2020. All rights reserved. Ordnance Survey Licence 0100031673.</p> | <p>Existing Crossing: Yes Crossing Type (existing): Circular Culvert Crossing Material (existing): Plastic Crossing Condition (existing): Average Channel Type: None evident, Poorly defined Gradient: Gentle Valley form: No obvious valley sides Bank condition: Stable Bed material: Vegetation Riparian corridor: Heavily Vegetated (e.g. gorse, bramble) Flow condition: Stagnant</p> <p>Culvert Dimensions: 0.45 m Water width: 0.3 m Water depth: Dry Bankfull width: 0.5 m Bankfull height: n/a Banktop height: n/a Flooded Bankfull width: 1 m</p> <p>Notes: very overgrown, no water flow present.</p> <p>CAR Auth Level: GBR Proposed Crossing Type: Circular Culvert</p> |

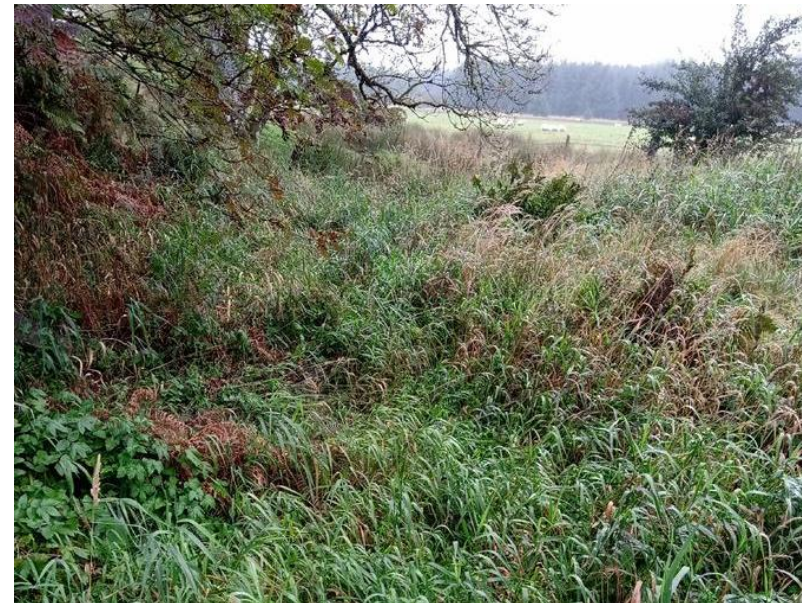
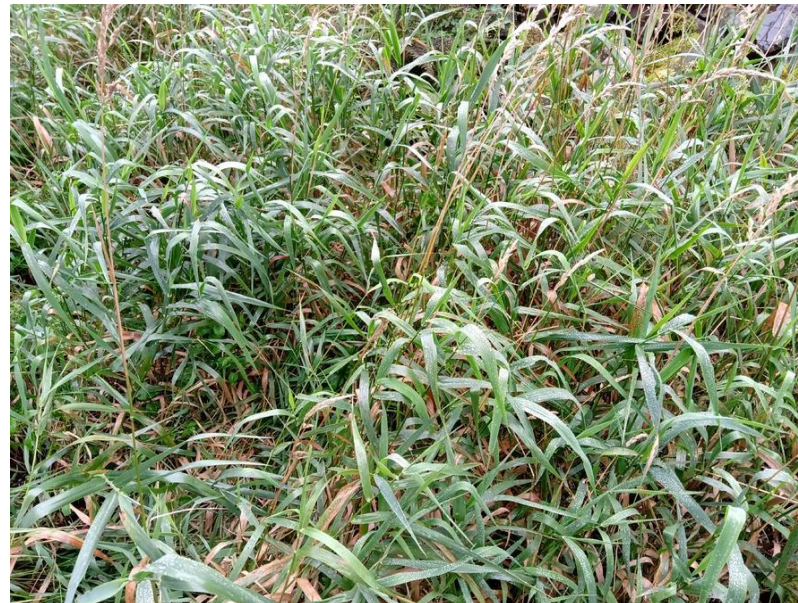
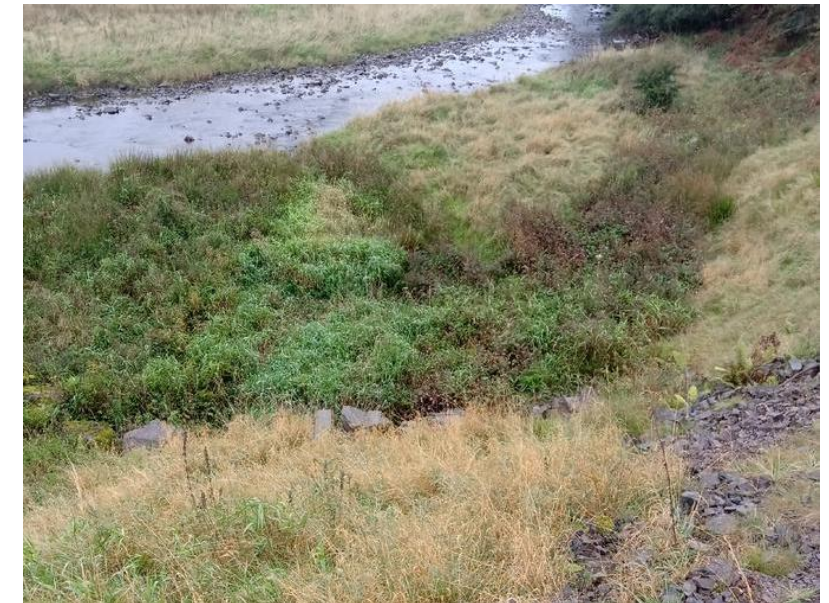
| WCX26 (307183,598136) | |
|---|--|
| <p>© Crown Copyright 2020. All rights reserved. Ordnance Survey Licence 0100031673.</p> | <p>Existing Crossing: Yes Crossing Type (existing): Circular Culvert Crossing Material (existing): Plastic Crossing Condition (existing): Good Channel Type: Poorly defined, Incised Gradient: Gentle Valley form: No obvious valley sides, Shallow vee Bank condition: Stable Bed material: Vegetation Riparian corridor: Agricultural Grazing Flow condition: Very slow</p> <p>Culvert Dimensions: 1.3 m Water width: 0.3-1 m Water depth: 0.05 m Bankfull width: 1-2 m Bankfull height: 0.05-0.15 m Flooded Bankfull width: 2-4 m Flooded Bankfull height: 0.15-0.5 m</p> <p>Notes: fen-like watercourse, dense vegetation.</p> <p>CAR Auth Level: GBR Proposed Crossing Type: Circular Culvert</p> |

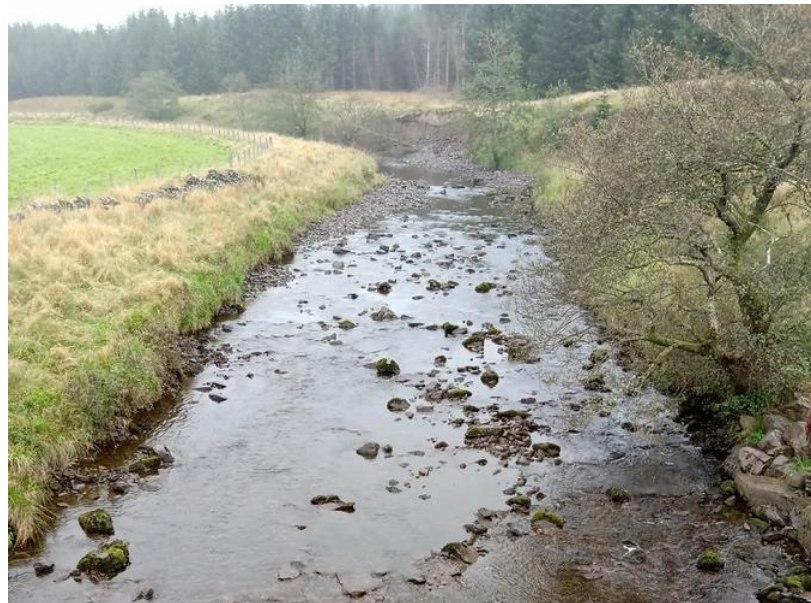
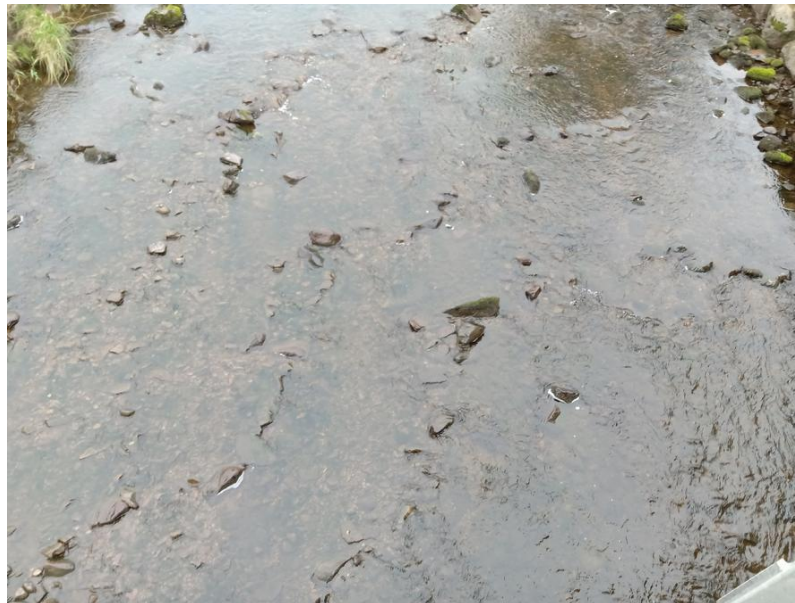
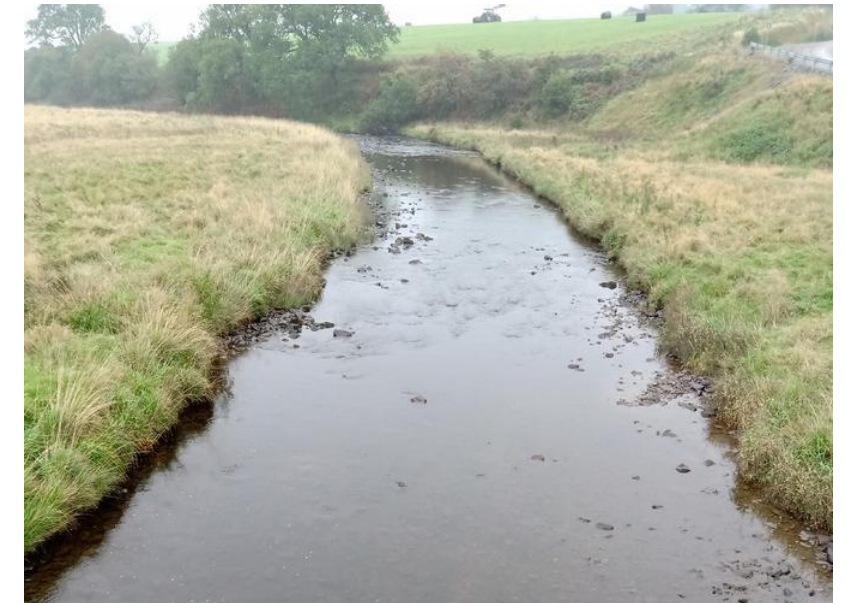
Table 8.1.21: Crossing WCX27

| WCX27 (307256,598168) | |
|---|---|
| <p>© Crown Copyright 2020. All rights reserved. Ordnance Survey Licence 0100031673.</p> | <p>Existing Crossing: Yes Crossing Type (existing): Bridge (no in channel support) Crossing Material (existing): Concrete and metal Crossing Condition (existing): Good Channel Type: Incised, Broad Gradient: Gentle Valley form: Shallow vee Bank condition: Stable Bed material: Fine sand/silt, Rounded pebbles, Coarse gravel, Boulders Riparian corridor: Commercial Forestry, Agricultural Grazing Flow condition: Moderate</p> <p>Water width: 8 m Water depth: 0.25 m Bankfull width: 8 m Bankfull height: 0.5 m Flooded Bankfull width: 8-12 m Flooded Bankfull height: 0.5-1 m</p> <p>Notes: Single span bridge.</p> <p>CAR Auth Level: No upgrade anticipated. Any minor works compliant with GBR9. Proposed Crossing Type: Existing Bridge</p> |
