Casing Repair as an Alternative to Buying New

Client	RWE, Didcot B
Location	United Kingdom
Expertise	Novel Weld Solutions, Microstructural Assessment, Fabrication and Machining

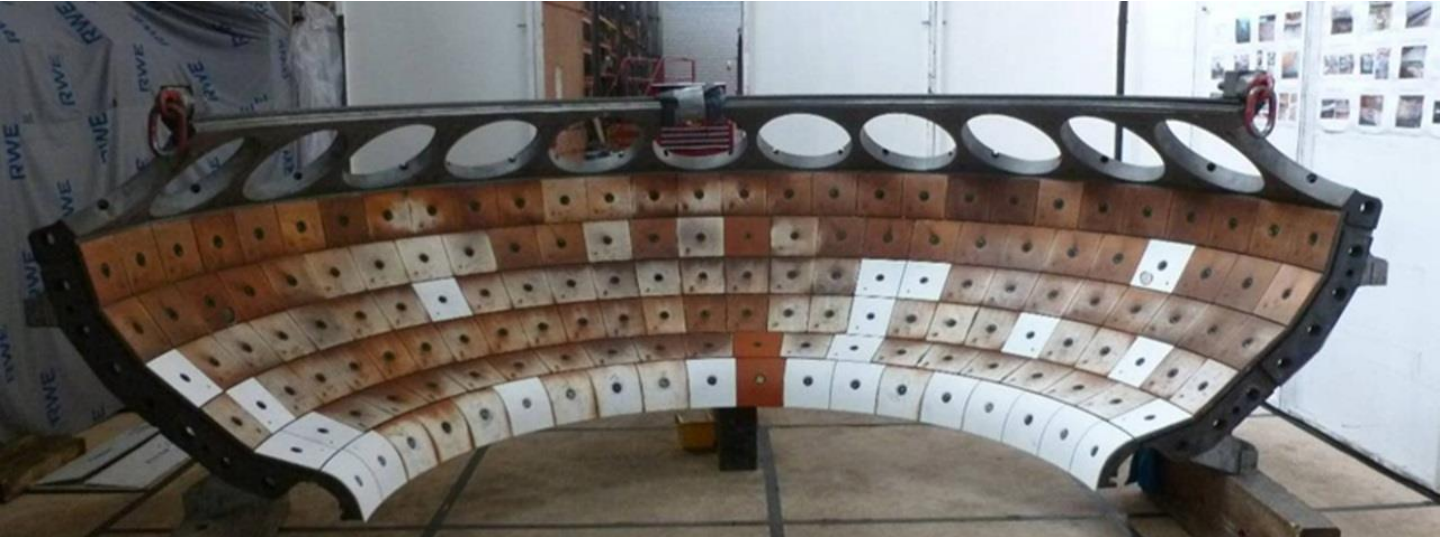
The casing had suffered extensive metal burning (oxidation) from a loss of a heat shield tile. The OEM was not able to offer a replacement metallic combustion casing and only offered a ceramic casing, which came with a big price tag and delivery timescales.

RWE Engineering reviewed the condition of the casing and established that a weld repair option could be feasible within the Station timescales. The casing was removed from Didcot and transported to RWE Ferrybridge Workshop (GMOS). A metallurgical examination of the casing was performed after localised grinding and hardness testing to determine the extent of the damage via replication techniques. At the same time, weld procedures were developed for the repair technique. The casing was successfully excavated to remove all damaged material followed by weld build-up, PWHT, machining to the final profile and NDT of the casing body. A bonus of undertaking this work is that the casing was up-graded to enable better cooling of the heat shield tiles. The repaired casing was returned within 9 weeks, ready for the machine re-build.

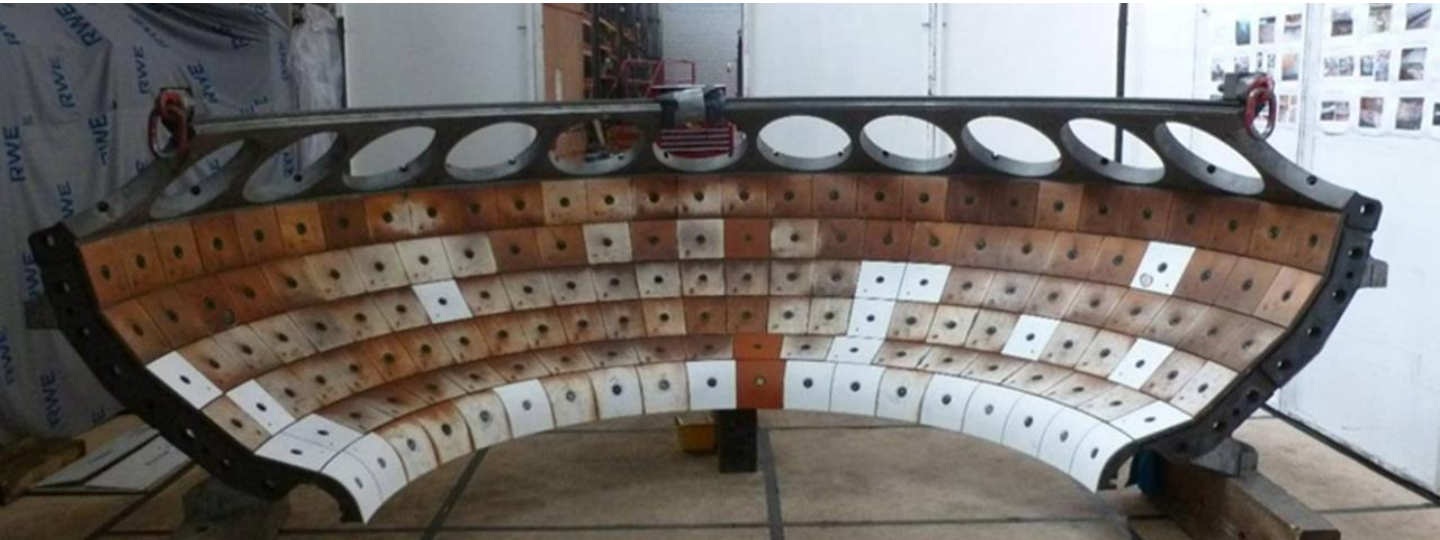
Das Gehäuse erlitt durch den Verlust einer Hitzeschutzkachel einen starken Metallbrand (Oxidation) und der OEM war nicht im Stande ein Brennkammergehäuse aus Metall anzubieten. Er bot nur ein Keramikgehäuse an, was zudem mit einem hohen Preis und langen Lieferzeiten verbunden war.

RWE Ingenieure überprüften den Zustand des Gehäuses und stellten fest, dass eine Schweißreparatur innerhalb der Vorgabezeit für die Anlage möglich ist. Das Gehäuse wurde in Didcot abmontiert und zum RWE Ferrybridge Workshop (GMOS) transportiert. Nach lokalem Schleifen und Härteprüfung wurde mittels Replikationstechniken eine metallurgische Untersuchung des Gehäuses durchgeführt, um das Schadensausmaß zu bestimmen. Gleichzeitig wurden Schweißverfahren für die Reparatur entwickelt. Das Gehäuse wurde erfolgreich ausgehoben, um das gesamte beschädigte Material zu entfernen. Danach erfolgte der Schweißnahtaufbau mit anschließender Wärmebehandlung, die mechanische Bearbeitung auf das endgültige Profil und ZfP des Gehäusekörpers.

Ein weiterer Nutzen dieser Arbeit ist ein Upgrade des Gehäuses, das eine bessere Kühlung der Hitzeschutzkacheln ermöglicht. Das reparierte Gehäuse wurde innerhalb von 9 Wochen zurückgebracht, bereit für den Wiedereinbau in die Maschine.
