Mining Maintenance Management

Copper Mine Maintenance Audit

Cia. Minera Doña Ines de Collahuasi

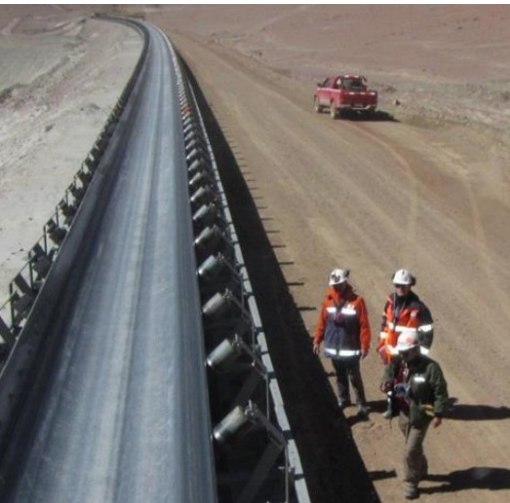
- Audit of the maintenance status of the conveyors within the mine and the concentrator.

- Audit of the entire system considering operation and maintenance of conveyors
- Suggest improvements and corrections in order to increase productivity
