## Generator rotor end ring inspection

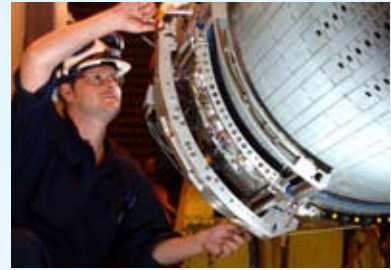
A bespoke computerised ultrasonic and eddy current inspection procedure linking powerful data acquisition and analysis software with a purpose designed scanner for fast, accurate, end ring inspection results either in situ or ex-situ of stator housings.

- low profile scanner design fits between end ring and stator
- recorded ultrasonic data displayed in A, B, C, and D scan formats enabling 'focussed' analysis on critical shrink fit areas
- multiple ultrasonic probe array enables a number of simultaneous pulse echo and time of flight diffraction scans
- eddy current probe array used to carry out external surface inspection
- permanent electronic records provide an auditable fingerprint
- system verified on sample end ring with known defects.
